## General Information

| Make | Mitsubishi | Model | Mirage |
| Registration No. | CCR8644 | Chassis No. | PAEA13RJTSA015399 |

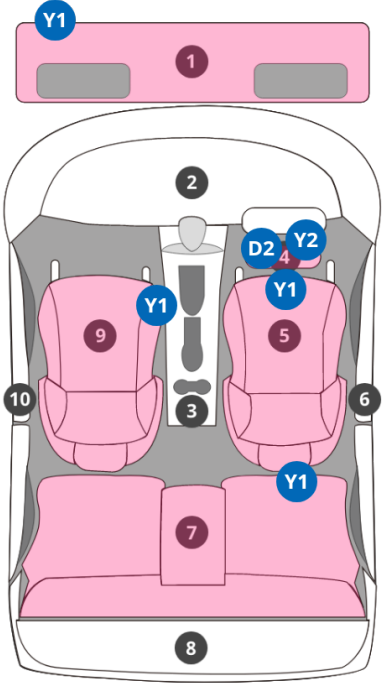
| Interior Evaluation : <b>A</b> | Exterior Evaluation : <b>C</b> |
|---|---|
| <p><b>Remarks</b></p> <p>(L) Front Seat - Grime - Minimal / (R) Front Seat - Grime - Minimal / Rear Seat - Grime - Minimal / (L) Front Floor Mat - Worked - Small / Ceiling - Grime - Minimal / (R) Front Floor Mat - Grime - Small</p> | <p><b>Remarks</b></p> <p>(R) Front Fender - Repair Traces - Yes / Bonnet - Repair Traces - Yes / (L) Front Fender - Repair Traces - Yes / (R) Front Fender, Molding - Scratch - Minimal / (R) Step, In-panel, Side Spoiler - Scratch - Minimal / (R) Rear Door, Molding - Scratch - Small / (R) Front Door, Molding - Scratch - Minimal / (R) Rear Fender, Molding - Scratch - Small / Rear Bumper, Lamps, Panels - Scratch - Medium / (L) Rear Fender, Molding - Scratch - Minimal / Trunk Hood, Rear Gate - Scratch - Minimal / (L) Rear Door, Molding - Scratch - Small / (L) Step, In-panel, Side Spoiler - Scratch - Minimal / (L) Front Door, Molding - Scratch - Minimal / (L) Front Fender, Molding - Scratch - Small / Front Bumper, Grille, Lamps - Scratch - Small / Bonnet, Headlight - Scratch - Medium / Roof - Scratch - Minimal</p> |
