## General Information

| Make | Mitsubishi | Model | L300 |
| Registration No. | NLC2312 | Chassis No. | PAEL65NYTSB010667 |

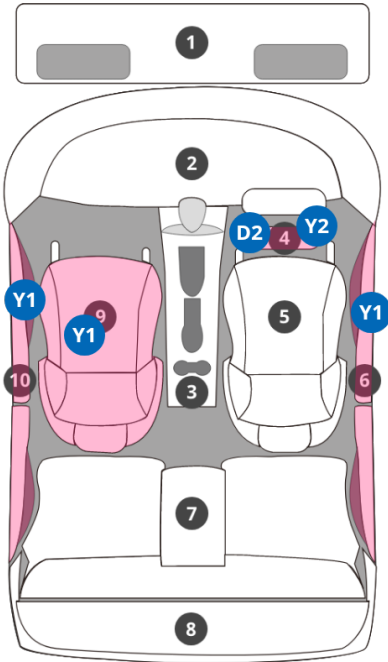
| Interior Evaluation : <b>A</b> | Exterior Evaluation : <b>C</b> |
|---|---|
| <p><b>Remarks</b><br/>(R) Front Floor Mat - Grime - Small / (L) Front Floor Mat - Worked - Small / (L) Front Seat - Grime - Minimal / (L) Front Trim - Grime - Minimal / (R) Front Trim - Grime - Minimal</p> | <p><b>Remarks</b><br/>(L) Front Fender, Molding - Scratch - Minimal / (L) Front Door, Molding - Scratch - Small / (L) Step, In-panel, Side Spoiler - Scratch - Small / (L) Center Panel - Scratch - Minimal / (L) Side Gate - Scratch - Small / Rear Bumper, Lamps, Panels - Rust, Corrosion - Small / Cargo Bed Floor - Scratch - Small / (R) Side Gate - Repair mark - Yes / (R) Side Gate - Scratch &amp; Dent - Small / (R) Front Door, Molding - Scratch - Small / (R) Step, In-panel, Side Spoiler - Scratch - Small / (R) Front Fender, Molding - Scratch - Minimal / Front Bumper, Grille, Lamps - Scratch - Medium / Front Panel - Scratch - Minimal / Roof - Scratch - Minimal</p> |

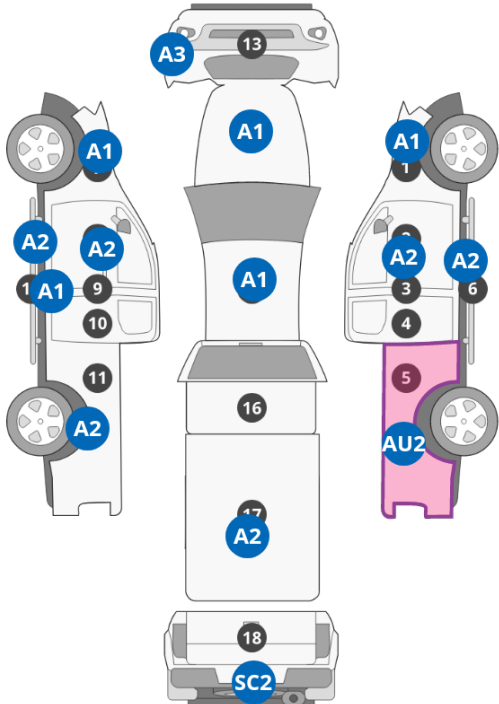
| Inspector Notes |
|---|
| with LTO plate/with warranty booklet/with tools and jack/with spare tire/acid rain on the body/hairline scratches on the body/with spare key |
