## General Information

| Make | Mitsubishi | Model | L300 |
| Registration No. | NLB1721 | Chassis No. | PAEL65NYTSB010399 |

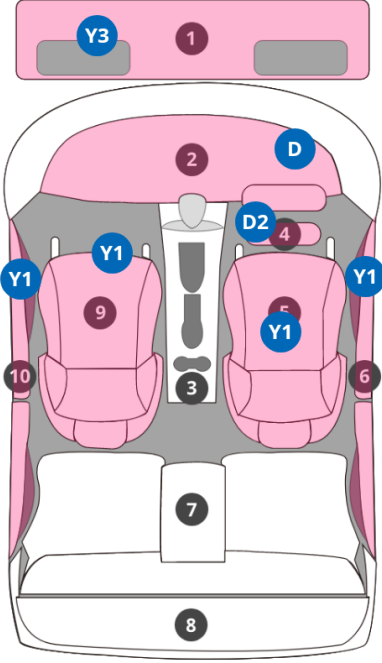
| Interior Evaluation : <b>B</b> | Exterior Evaluation : <b>B</b> |
|---|---|
| <b>Remarks</b><br>Sunvisor, Sunglass Holder - Grime - Medium / Dashboard - Traces of Adhesive Tape - Yes / (L) Front Seat - Grime - Minimal / (R) Front Seat - Grime - Minimal / (L) Front Trim - Grime - Minimal / (R) Front Trim - Grime - Minimal / (L) Front Floor Mat - Worked - Small | <b>Remarks</b><br>(R) Front Fender, Molding - Scratch - Minimal / (R) Front Door, Molding - Scratch - Minimal / (R) Center Panel - Scratch - Minimal / (R) Side Gate - Scratch - Medium / Rear Gate - Scratch - Minimal / Cargo Bed Floor - Scratch & Dent - Medium / (L) Side Gate - Scratch - Small / (L) Center Panel - Scratch - Minimal / (L) Front Door, Molding - Scratch - Minimal / (L) Front Fender, Molding - Scratch - Minimal / Front Bumper, Grille, Lamps - Scratch - Minimal / Roof - Scratch - Minimal |

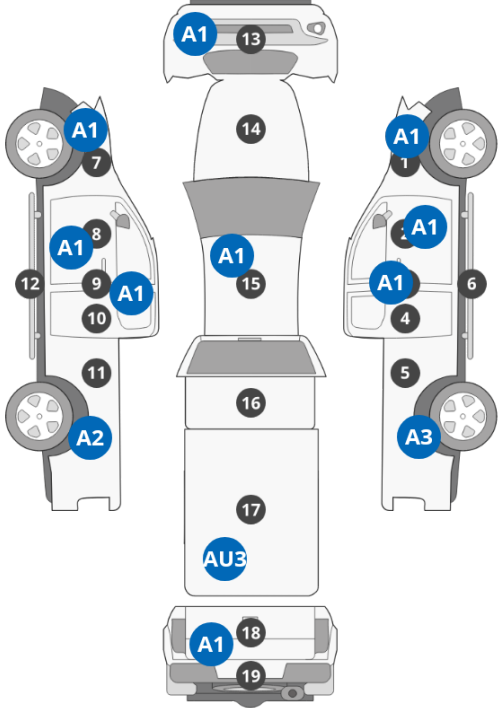
| Inspector Notes |
|---|
| with Ito plate/with warranty booklet/with spare tire/with hairlines scratches on the body/without spare key/without tools and jack/without reverse camera |
