## General Information

| Make | Mitsubishi | Model | L300 |
| Registration No. | NLA7960 | Chassis No. | PAEL65NYTSB010058 |

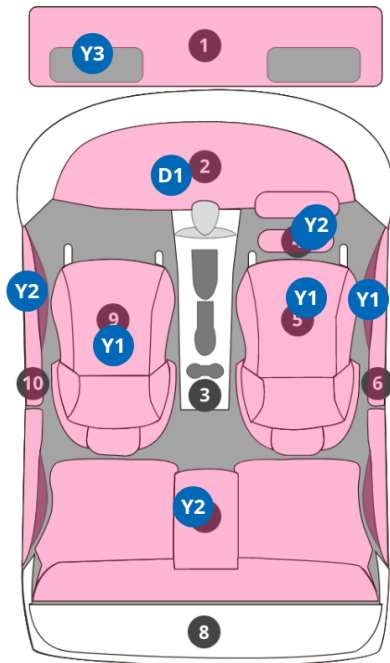
| Interior Evaluation : <b>B</b> | Exterior Evaluation : <b>D</b> |
| <b>Remarks</b><br>(L) Front Floor Mat - Grime - Minimal / (R) Front Floor Mat - Grime - Small / Rear Seat - Grime - Small / (L) Front Seat - Grime - Minimal / (R) Front Seat - Grime - Minimal / Sunvisor, Sunglass Holder - Grime - Medium / (L) Front Trim - Grime - Small / (R) Front Trim - Grime - Minimal | <b>Remarks</b><br>(L) Rear Corner Panel - Repair Traces - Yes / Front Panel - Scratch - Small / Front Bumper, Grille, Lamps - Scratch & Dent - Small / (L) Front Door, Molding - Scratch - Small / (L) Center Panel - Scratch & Dent - Minimal / (L) Side Gate - Scratch & Dent - Medium / Rear Bumper, Lamps, Panels - Scratch & Dent - Small / Cargo Bed Floor - Scratch - Medium / Rear Gate - Repair mark - Yes / Rear Gate - Scratch & Dent - Small / (R) Side Gate - Scratch & Dent - Small / (R) Center Panel - Scratch - Small / (R) Front Door, Molding - Scratch & Dent - Small / (R) Front Fender, Molding - Scratch - Small / (L) Front Fender, Molding - Scratch - Minimal / Roof - Scratch & Dent - Small |
