## General Information

| Make | Mitsubishi | Model | L300 |
| YOM | 2026 | Odo Meter Reading | 14,646 |
| Registration No. | NLB7696 | Chassis No. | PAEL65NYTSB010421 |

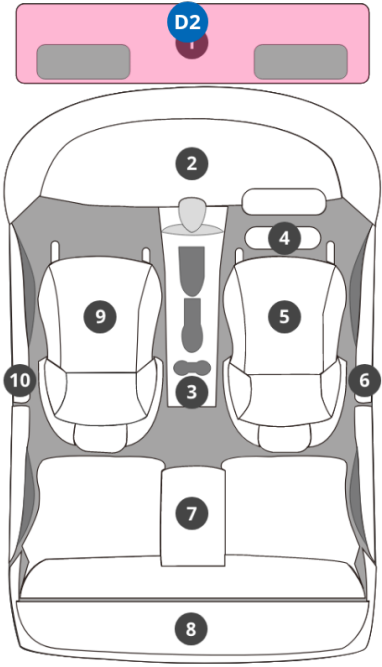
| Interior Evaluation : <span style="color: red; font-weight: bold;">A</span> | Exterior Evaluation : <span style="color: red; font-weight: bold;">E</span> |
| <b>Remarks</b><br>Ceiling - Crinkle - Small | <b>Remarks</b><br>(L) Rear Corner Panel - Repair Traces - Yes / (R) Front Fender, Molding - Scratch - Minimal / (R) Front Door, Molding - Scratch - Small / (R) Center Panel - Scratch - Small / (R) Side Gate - Scratch & Dent - Large / Rear Bumper, Lamps, Panels - Rust, Corrosion - Medium / Rear Gate - Scratch - Medium / Cab Back Panel - Scratch & Dent - Large / Cargo Bed Floor - Scratch - Medium / (L) Side Gate - Scratch & Dent - Large / (L) Front Door, Molding - Scratch & Dent - Small / (L) Center Panel - Scratch - Small / (L) Mirror - Scratch - Minimal / (L) Front Fender, Molding - Scratch - Minimal / Front Bumper, Grille, Lamps - Scratch & Dent - Medium / Front Panel - Scratch - Minimal / Roof - Scratch - Minimal |
