## General Information

| Make | Mitsubishi | Model | L300 |
| Registration No. | NKS4652 | Chassis No. | PAEL65NYSSB005311 |

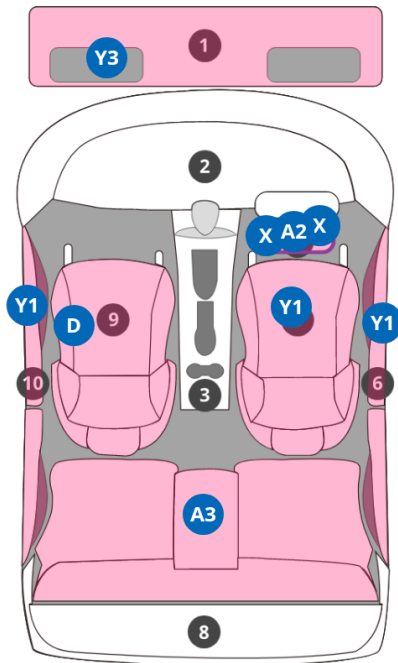
| Interior Evaluation : <span style="color: red; font-weight: bold;">B</span> | Exterior Evaluation : <span style="color: red; font-weight: bold;">C</span> |
| <p><b>Remarks</b></p> <p>Rear Seat - Cut, Crack - Medium / (L) Front Seat - Worn - Yes / (R) Front Seat - Grime - Minimal / (R) Front Floor Mat - Missing - Yes / (L) Front Floor Mat - Missing - Yes / Carpet - Worn, Scratch, Cut, Crack - Small / (R) Front Trim - Grime - Minimal / (L) Front Trim - Grime - Minimal / Sunvisor, Sunglass Holder - Grime - Medium</p> | <p><b>Remarks</b></p> <p>(R) Step, In-panel, Side Spoiler - Scratch - Small / (R) Front Door, Molding - Scratch - Small / (R) Side Gate - Scratch - Small / Rear Bumper, Lamps, Panels - Rust, Corrosion - Small / Cargo Bed Floor - Scratch - Small / Rear Gate - Scratch - Small / (L) Side Gate - Scratch &amp; Dent - Small / (L) Front Door, Molding - Scratch - Small / (L) Step, In-panel, Side Spoiler - Scratch - Small / (L) Front Fender, Molding - Scratch - Minimal / (R) Front Fender, Molding - Scratch - Minimal / Front Panel - Scratch - Minimal / Front Bumper, Grille, Lamps - Scratch - Small / Roof - Scratch - Minimal</p> |
