## General Information

| Make | Toyota | Model | Vios |
| YOM | 2025 | Odo Meter Reading | 30,156 |
| Registration No. | GBF7180 | Chassis No. | PA1B18F33R4277063 |

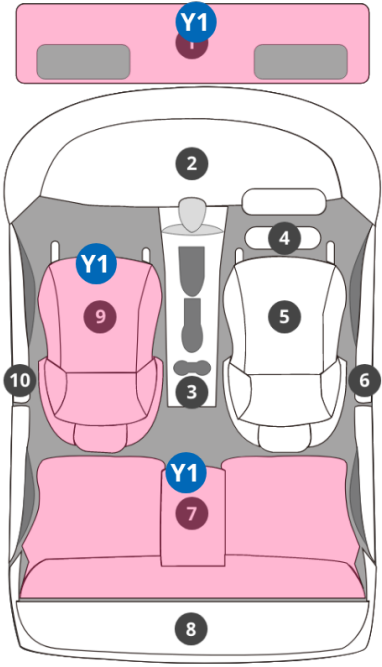
| Interior Evaluation : <b>A</b> | Exterior Evaluation : <b>E</b> |
| <b>Remarks</b><br>(L) Front Seat - Grime - Minimal / Rear Seat - Grime - Minimal / Ceiling - Grime - Minimal | <b>Remarks</b><br>(R) Front Door - Repair Traces - Yes / (R) Front Fender - Repair Traces - Yes / Bonnet - Repair Traces - Yes / (L) Front Fender - Repair Traces - Yes / (L) Front Door - Repair Traces - Yes / (L) Rear Door - Repair Traces - Yes / (L) Rear Fender - Repair Traces - Yes / Trunk Hood, Rear Gate - Repair Traces - Yes / (R) Rear Fender - Repair Traces - Yes / (R) Rear Door - Repair Traces - Yes / Roof - Repair Traces - Yes / (R) Front Fender, Molding - Crack, Gap - Small / (R) Front Door, Molding - Scratch - Large / (R) Step, In-panel, Side Spoiler - Scratch & Dent - Large / (R) Rear Fender, Molding - Scratch - Large / (R) Rear Fender, Molding - Repair mark - Yes / Rear Bumper, Lamps, Panels - Repair mark - Yes / Rear Bumper, Lamps, Panels - Scratch & Dent - Large / (L) Rear Fender, Molding - Scratch - Medium / (R) Rear Door, Molding - Repair mark - Yes / (L) Rear Door, Molding - Scratch & Dent - Small / (L) Front Door, Molding - Scratch - Minimal / Front Bumper, Grille, Lamps - Repair mark - Yes |
