## General Information

| Make | Suzuki | Model | Dzire |
| Registration No. | FAS7266 | Chassis No. | MBHZF63SXS591321 |

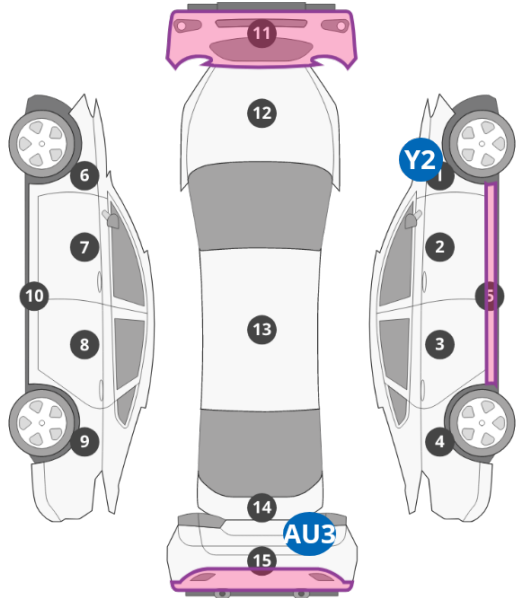
| Interior Evaluation : <b>A</b> | Exterior Evaluation : <b>B</b> |
|---|---|
| <b>Remarks</b><br>Rear Seat - Grime - Minimal / Ceiling - Grime - Minimal | <b>Remarks</b><br>(R) Front Door - Repair Traces - Yes / (R) Step - Repair Traces - Yes / (R) Step - Replaced - Yes / (R) Front Fender - Repair Traces - Yes / Bonnet - Repair Traces - Yes / (L) Front Fender - Repair Traces - Yes / (L) Front Door - Repair Traces - Yes / (L) Rear Door - Repair Traces - Yes / (L) Rear Fender - Repair Traces - Yes / Trunk Hood, Rear Gate - Repair Traces - Yes / (R) Rear Fender - Repair Traces - Yes / (R) Rear Door - Repair Traces - Yes / Roof - Repair Traces - Yes / (R) Front Fender, Molding - Crack, Gap - Small / Trunk Hood, Rear Gate - Scratch & Dent - Medium / Rear Bumper, Lamps, Panels - Repair mark - Yes / Front Bumper, Grille, Lamps - Repair mark - Difference in Color |

with Ito plate, with warranty booklet, with spare tire, with jack and tools, with hairline scratches in the body
