## General Information

| Make | Toyota | Model | Avanza |
| Registration No. | NJJ1039 | Chassis No. | MHFAA1BY3S0044964 |

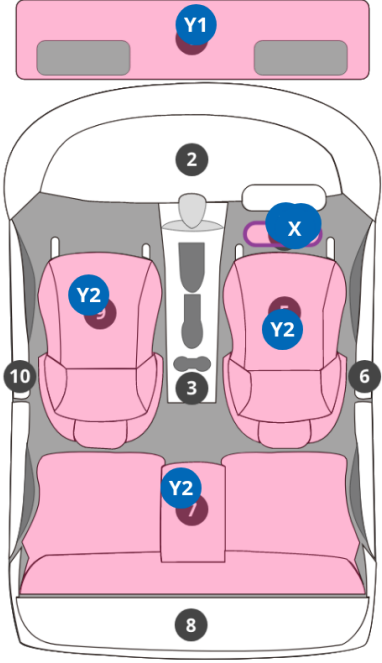
| Interior Evaluation : <b>B</b> | Exterior Evaluation : <b>E</b> |
|---|---|
| <b>Remarks</b><br>(L) Front Floor Mat - Missing - Yes / (R) Front Floor Mat - Missing - Yes / Mat Other - Missing - Yes / Rear Seat - Grime - Small / (R) Front Seat - Grime - Small / (L) Front Seat - Grime - Small / Ceiling - Grime - Minimal | <b>Remarks</b><br>(R) Front Fender - Repair Traces - Yes / Bonnet - Repair Traces - Yes / (L) Front Fender - Repair Traces - Yes / (L) Step, In-panel, Side Spoiler - Scratch & Dent - Large / (L) Rear Door, Molding - Scratch & Dent - Large / (L) Front Door, Molding - Scratch & Dent - Medium / Roof - Scratch & Dent - Small / (L) Rear Fender, Molding - Scratch & Dent - Medium / (L) Front Fender, Molding - Scratch & Dent - Minimal / Front Bumper, Grille, Lamps - Repair mark - Yes / Front Bumper, Grille, Lamps - Crack, Gap - Small / Bonnet, Headlight - Scratch & Dent - Minimal / Trunk Hood, Rear Gate - Scratch & Dent - Small / Rear Bumper, Lamps, Panels - Scratch - Medium / (R) Rear Fender, Molding - Scratch & Dent - Minimal / (R) Rear Door, Molding - Scratch - Small / (R) Front Door, Molding - Scratch & Dent - Small / (R) Step, In-panel, Side Spoiler - Scratch - Small / (R) Front Fender, Molding - Scratch - Small |

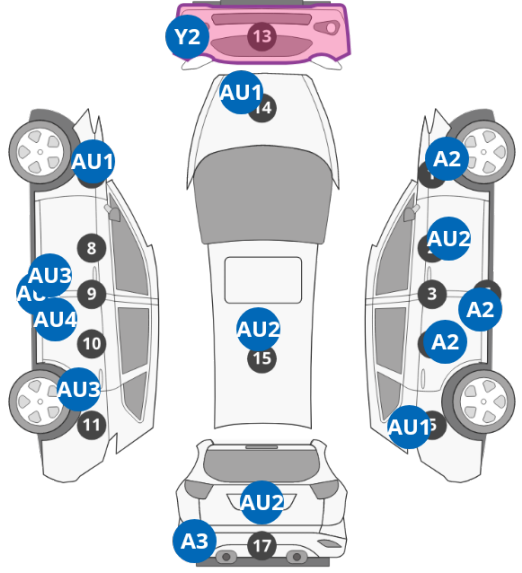
| Inspector Notes |
|---|
| with LTO plate, with reverse camera, with manual and warranty booklet, no tools and jack, no spare key, scratches and dent on exterior, scratches in taillight and headlight. |
