## General Information

| Make | Toyota | Model | Avanza |
| Registration No. | NHS5169 | Chassis No. | MHFAA1BYXR0028609 |

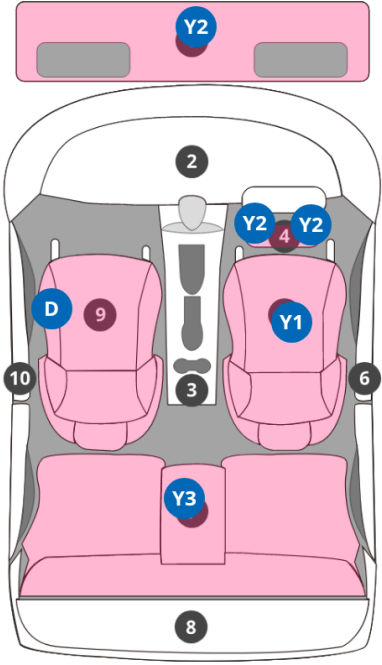
| Interior Evaluation : <b>B</b> | Exterior Evaluation : <b>E</b> |
|---|---|
| <p><b>Remarks</b></p> <p>Rear Seat - Grime - Medium / (R) Front Seat - Grime - Minimal / (R) Front Floor Mat - Grime - Small / (L) Front Seat - Worn - Yes / (L) Front Floor Mat - Grime - Small / Ceiling - Grime - Small</p> | <p><b>Remarks</b></p> <p>(R) Front Door - Repair Traces - Yes / (R) Step - Repair Traces - Yes / (R) Front Fender - Repair Traces - Yes / (L) Front Fender - Repair Traces - Yes / (R) Rear Door - Repair Traces - Yes / (R) Step, In-panel, Side Spoiler - Repair mark - Yes / (R) Front Fender, Molding - Repair mark - Yes / (R) Front Door, Molding - Repair mark - Yes / (R) Rear Door, Molding - Repair mark - Yes / Bonnet, Headlight - Scratch - Small / (L) Front Fender, Molding - Scratch - Minimal / (L) Front Door, Molding - Scratch - Small / (L) Step, In-panel, Side Spoiler - Scratch &amp; Dent - Large / (L) Mirror - Scratch - Minimal / (L) Rear Door, Molding - Scratch &amp; Dent - Small / (L) Rear Fender, Molding - Scratch &amp; Dent - Minimal / Trunk Hood, Rear Gate - Scratch - Minimal / Rear Bumper, Lamps, Panels - Scratch - Large / (R) Rear Fender, Molding - Scratch &amp; Dent - Medium / (R) Rear Door, Molding - Scratch &amp; Dent - Large / (R) Step, In-panel, Side Spoiler - Scratch - Small / (R) Mirror - Scratch - Minimal / (R) Front Door, Molding - Scratch - Small / (R) Front Fender, Molding - Scratch &amp; Dent - Small / Front Bumper, Grille, Lamps - Scratch - Medium / Roof - Scratch - Small</p> |
