## General Information

| Make | Mitsubishi | Model | L300 |
| Registration No. | NJM1203 | Chassis No. | PAEL65NYTSB012153 |

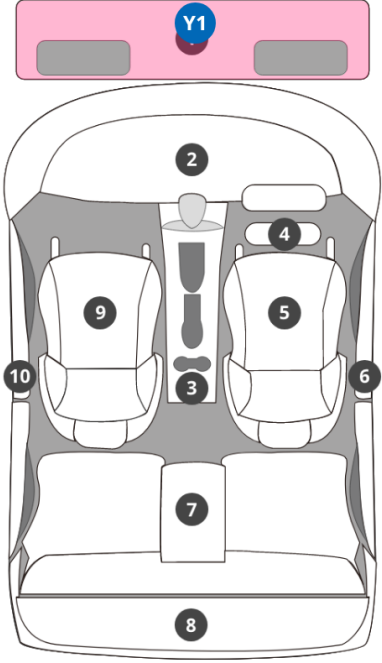
| Interior Evaluation : <b>A</b> | Exterior Evaluation : <b>C</b> |
| <b>Remarks</b><br>Ceiling - Grime - Minimal | <b>Remarks</b><br>(L) Rear Corner Panel - Repair Traces - Yes / (R) Front Door, Molding - Scratch & Dent - Minimal / (R) Step, In-panel, Side Spoiler - Scratch - Minimal / (R) Side Gate - Scratch - Large / Rear Gate - Scratch & Dent - Minimal / Rear Bumper, Lamps, Panels - Scratch - Minimal / Cargo Bed Floor - Scratch - Small / (L) Side Gate - Scratch - Small / Roof - Scratch - Large / (L) Front Door, Molding - Scratch - Large / Front Bumper, Grille, Lamps - Scratch - Medium |
