## General Information

| Make | Toyota | Model | Avanza |
| Registration No. | DBT8677 | Chassis No. | MHFAB1BY5S3136640 |

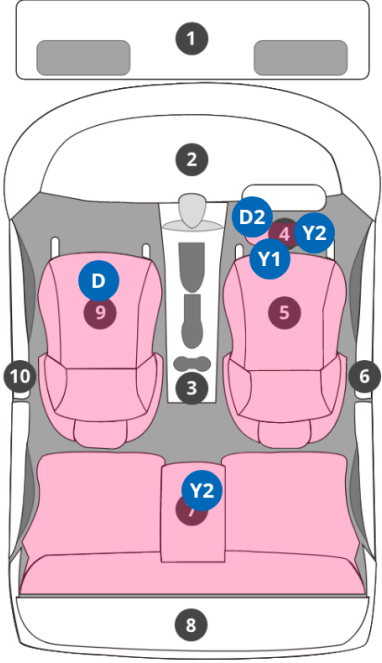
| Interior Evaluation : <b>B</b> | Exterior Evaluation : <b>C</b> |
| <p><b>Remarks</b><br/>Rear Seat - Grime - Small / (R) Front Seat - Grime - Minimal / (R) Front Floor Mat - Grime - Small / (L) Front Seat - Worn - Yes / (L) Front Floor Mat - Worked - Small</p> | <p><b>Remarks</b><br/>(R) Rear Fender - Repair Traces - Yes / (R) Rear Fender, Molding - Repair mark - Yes / (L) Front Fender, Molding - Scratch - Minimal / (L) Mirror - Scratch - Minimal / (L) Step, In-panel, Side Spoiler - Scratch - Small / (L) Front Door, Molding - Scratch - Small / (L) Rear Door, Molding - Scratch - Minimal / (L) Rear Fender, Molding - Scratch - Minimal / Rear Bumper, Lamps, Panels - Repair mark - Yes / Rear Bumper, Lamps, Panels - Scratch - Small / (R) Rear Fender, Molding - Dent - Small / (R) Step, In-panel, Side Spoiler - Scratch - Small / (R) Rear Door, Molding - Scratch - Minimal / (R) Front Door, Molding - Scratch - Minimal / (R) Mirror - Scratch - Minimal / (R) Front Fender, Molding - Scratch - Minimal / Front Bumper, Grille, Lamps - Scratch - Small / Bonnet, Headlight - Scratch - Minimal / Roof - Scratch &amp; Dent - Small / (R) Front Door, Molding - Repair mark - Yes / (R) Rear Door, Molding - Repair mark - Yes / Trunk Hood, Rear Gate - Scratch - Minimal</p> |
