## General Information

| Make | Toyota | Model | Hilux Tamaraw |
| Registration No. | NJC3320 | Chassis No. | PAHACACA0S6423771 |

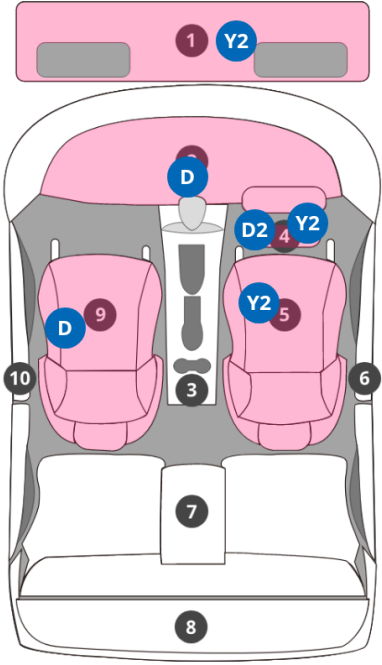
| Interior Evaluation : <b>B</b> | Exterior Evaluation : <b>E</b> |
| <b>Remarks</b><br>(R) Front Floor Mat - Grime - Small / (R) Front Seat - Grime - Small / (L) Front Seat - Worn - Yes / (L) Front Floor Mat - Worked - Small / Ceiling - Grime - Small / Dashboard - Traces of Adhesive Tape - Yes | <b>Remarks</b><br>(L) Front Fender, Molding - Scratch - Minimal / (L) Mirror - Scratch - Minimal / (L) Front Door, Molding - Scratch - Small / (L) Step, In-panel, Side Spoiler - Scratch - Small / (L) Side Gate - Scratch & Dent - Large / Rear Bumper, Lamps, Panels - Scratch - Large / Rear Gate - Scratch - Medium / Cargo Bed Floor - Scratch - Large / (R) Side Gate - Scratch & Dent - Large / (R) Step, In-panel, Side Spoiler - Scratch - Small / (R) Front Door, Molding - Scratch - Small / (R) Mirror - Scratch - Minimal / (R) Front Fender, Molding - Scratch - Small / Front Bumper, Grille, Lamps - Scratch - Medium / Bonnet, Headlight - Scratch - Minimal / Front Windshield - Damaged - Large / Roof - Dent - Small |
