## General Information

| Make | Toyota | Model | Innova |
| YOM | 2025 | Odo Meter Reading | 40,378 |
| Registration No. | NJF6921 | Chassis No. | PA2JA8EM6S0155831 |

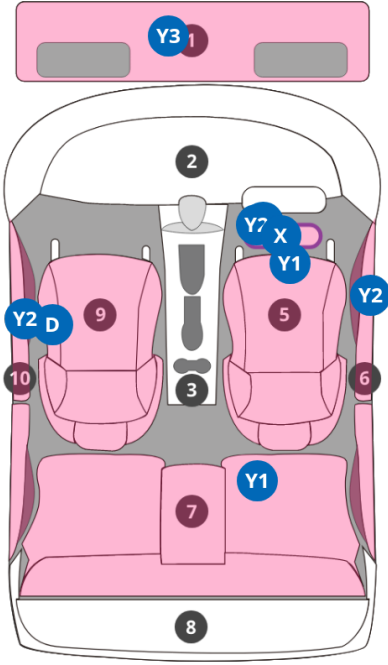
| Interior Evaluation : <b>B</b> | Exterior Evaluation : <b>E</b> |
| <p><b>Remarks</b></p> <p>(L) Front Seat - Worn - Yes / (R) Front Seat - Grime - Minimal / (L) Front Trim - Grime - Small / (R) Front Trim - Grime - Small / Ceiling - Grime - Medium / (L) Front Floor Mat - Worked - Small / (L) Front Floor Mat - Grime - Small / Mat Other - Missing - Yes / Rear Seat - Grime - Minimal</p> | <p><b>Remarks</b></p> <p>Trunk Hood, Rear Gate - Repair Traces - Yes / (R) Front Fender, Molding - Scratch - Small / (R) Mirror - Scratch - Minimal / (R) Step, In-panel, Side Spoiler - Scratch &amp; Dent - Medium / (R) Front Door, Molding - Scratch - Medium / (R) Rear Door, Molding - Scratch - Small / (R) Rear Fender, Molding - Scratch - Medium / Rear Bumper, Lamps, Panels - Repair mark - Yes / Rear Bumper, Lamps, Panels - Scratch - Small / Trunk Hood, Rear Gate - Scratch - Minimal / (L) Rear Fender, Molding - Scratch - Medium / (L) Front Door, Molding - Scratch - Medium / (L) Rear Door, Molding - Scratch - Small / (L) Mirror - Scratch - Small / Front Bumper, Grille, Lamps - Repair mark - Yes / (L) Front Fender, Molding - Scratch - Minimal / Front Bumper, Grille, Lamps - Crack, Gap - Medium / Bonnet, Headlight - Scratch - Small / Roof - Dent - Medium</p> |

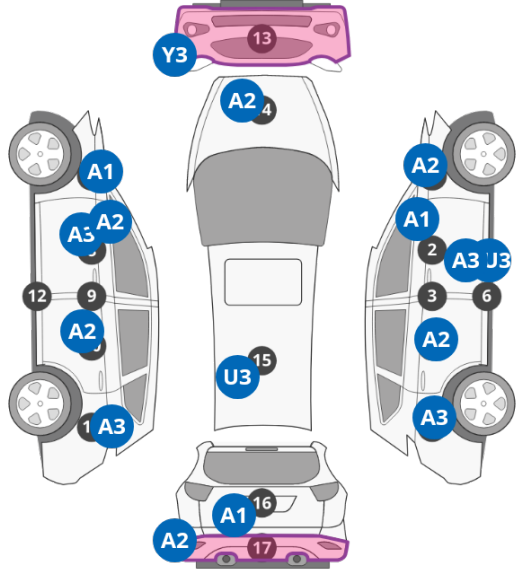
| Inspector Notes |
|---|
| no warranty booklet, with jack and tools, with spare tire, with LTO plate, scratched and cracked headlight, scratches on tail light, brake and tail light issue, |
