## General Information

| Make | Toyota | Model | Wigo |
| Registration No. | NEK9468 | Chassis No. | MHKAA1BC0SJ052892 |

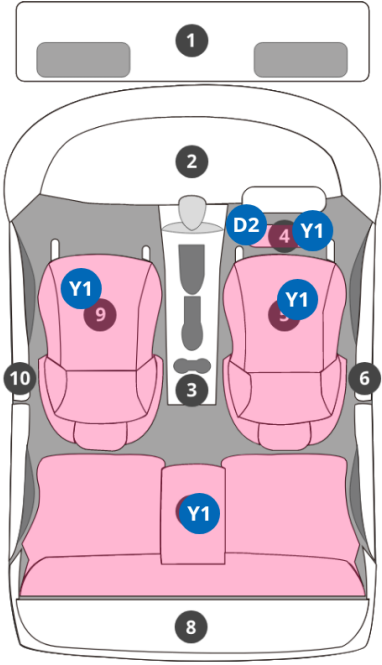
| Interior Evaluation : <b>A</b> | Exterior Evaluation : <b>C</b> |
| <p><b>Remarks</b><br/>(L) Front Seat - Grime - Minimal / (R) Front Seat - Grime - Minimal / Rear Seat - Grime - Minimal / (R) Front Floor Mat - Grime - Minimal / (L) Front Floor Mat - Worked - Small</p> | <p><b>Remarks</b><br/>(R) Front Fender - Repair Traces - Yes / (L) Front Fender - Repair Traces - Yes / (L) Front Fender, Molding - Repair mark - Yes / (R) Front Fender, Molding - Repair mark - Yes / (L) Front Fender, Molding - Scratch - Minimal / (L) Front Door, Molding - Scratch - Small / (L) Rear Door, Molding - Scratch - Small / (L) Rear Fender, Molding - Scratch - Minimal / Trunk Hood, Rear Gate - Scratch - Small / Rear Bumper, Lamps, Panels - Scratch - Small / (R) Rear Door, Molding - Scratch - Small / (R) Rear Fender, Molding - Scratch - Small / (R) Front Door, Molding - Scratch - Small / (R) Front Fender, Molding - Scratch &amp; Dent - Medium / Front Bumper, Grille, Lamps - Repair mark - Yes / Front Bumper, Grille, Lamps - Scratch - Small / Bonnet, Headlight - Scratch - Minimal / Roof - Scratch - Minimal / (L) Step, In-panel, Side Spoiler - Scratch - Minimal / (R) Step, In-panel, Side Spoiler - Scratch - Minimal</p> |
