## General Information

| Make | Toyota | Model | Vios |
| Registration No. | NFF2104 | Chassis No. | PA1B18F33P4233142 |

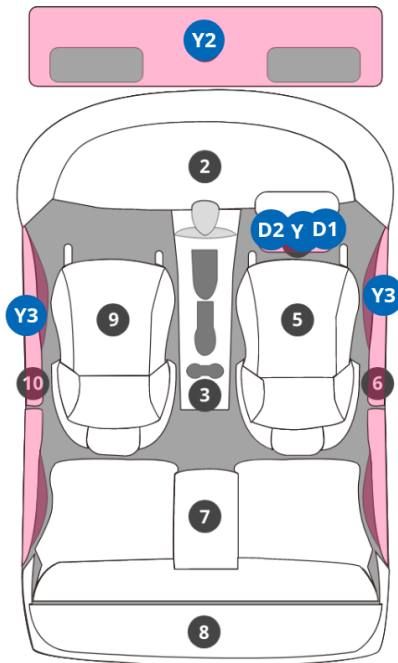
| Interior Evaluation : <b>B</b> | Exterior Evaluation : <b>E</b> |
|---|---|
| <p><b>Remarks</b></p> <p>Ceiling - Grime - Small / (R) Front Trim - Grime - Medium / (R) Front Floor Mat - Grime - Minimal / (L) Front Trim - Grime - Medium / (L) Front Floor Mat - Worked - Small / Carpet - Worked - Minimal</p> | <p><b>Remarks</b></p> <p>(L) Front Fender - Repair Traces - Yes / (L) Rear Door - Repair Traces - Yes / (R) Front Fender, Molding - Scratch - Minimal / (R) Mirror - Scratch - Minimal / (R) Front Door, Molding - Scratch - Medium / (R) Step, In-panel, Side Spoiler - Scratch &amp; Dent - Small / (R) Rear Door, Molding - Scratch &amp; Dent - Small / (R) Rear Fender, Molding - Scratch - Minimal / Rear Bumper, Lamps, Panels - Scratch &amp; Dent - Large / Trunk Hood, Rear Gate - Scratch &amp; Dent - Small / (L) Rear Fender, Molding - Scratch - Minimal / (L) Rear Door, Molding - Repair mark - Yes / (L) Rear Door, Molding - Scratch - Small / (L) Front Door, Molding - Scratch - Minimal / (L) Step, In-panel, Side Spoiler - Repair mark - Yes / (L) Step, In-panel, Side Spoiler - Scratch &amp; Dent - Small / (L) Mirror - Scratch - Minimal / (L) Front Fender, Molding - Repair mark - Yes / (L) Front Fender, Molding - Scratch &amp; Dent - Minimal / Front Bumper, Grille, Lamps - Scratch - Medium / Bonnet, Headlight - Scratch - Small / Roof - Repair mark - Yes / Roof Spoiler, Molding - Scratch - Minimal</p> |
