## General Information

| Make | Toyota | Model | Vios |
| YOM | 2023 | Odo Meter Reading | 59,745 |
| Registration No. | CBT4281 | Chassis No. | PA1B18F30P4202589 |

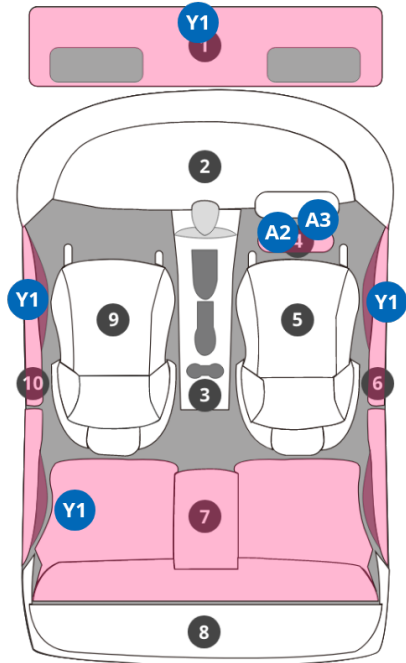
| Interior Evaluation : <b>B</b> | Exterior Evaluation : <b>D</b> |
|---|---|
| <b>Remarks</b><br>Rear Seat - Grime - Minimal / (R) Front Trim - Grime - Minimal / Ceiling - Grime - Minimal / (L) Front Trim - Grime - Minimal / Carpet - Worn, Scratch, Cut, Crack - Small / (L) Front Floor Mat - Cut, Crack - Medium | <b>Remarks</b><br>(R) Front Fender - Repair Traces - Yes / (R) Rear Fender - Repair Traces - Yes / Roof - Repair Traces - Yes / (R) Front Fender, Molding - Repair mark - Difference in Color / (R) Front Fender, Molding - Crack, Gap - Small / (R) Mirror - Scratch - Minimal / (R) Front Door, Molding - Scratch & Dent - Medium / (R) Step, In-panel, Side Spoiler - Scratch - Minimal / (R) Rear Door, Molding - Scratch & Dent - Small / (R) Rear Fender, Molding - Scratch & Dent - Medium / Rear Bumper, Lamps, Panels - Scratch & Dent - Large / (L) Rear Fender, Molding - Scratch & Dent - Minimal / (L) Rear Door, Molding - Scratch - Minimal / (L) Front Door, Molding - Scratch - Minimal / (L) Step, In-panel, Side Spoiler - Scratch - Minimal / (L) Front Fender, Molding - Scratch - Minimal / Front Bumper, Grille, Lamps - Scratch - Large / Bonnet, Headlight - Scratch - Minimal / Roof - Dent - Minimal / Trunk Hood, Rear Gate - Scratch - Minimal |
