## General Information

| Make | Nissan | Model | NP300 Navara |
| YOM | 2017 | Odo Meter Reading | 116,603 |
| Registration No. | NDE8701 | Chassis No. | MNTCC2D23Z0016710 |

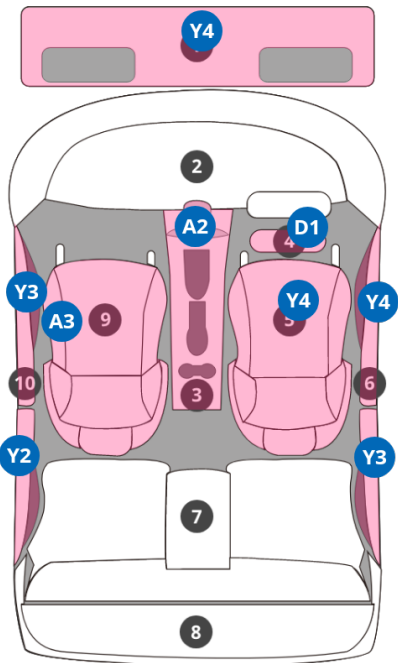
| Interior Evaluation : <span style="color: red;">D</span> | Exterior Evaluation : <span style="color: red;">E</span> |
| <b>Remarks</b><br>Ceiling - Grime - Large / (R) Rear Trim - Grime - Medium / (R) Front Trim - Grime - Large / (R) Front Seat - Grime - Large / Console, Switchs, Vents - Worn, Scratch, Cut, Crack - Small / (L) Rear Trim - Grime - Small / (L) Front Trim - Grime - Medium / (L) Front Seat - Cut, Crack - Medium / Carpet - Worked - Minimal | <b>Remarks</b><br>(R) Front Fender, Molding - Scratch & Dent - Large / (R) Mirror - Scratch - Minimal / (R) Front Door, Molding - Scratch & Dent - Minimal / (R) Rear Door, Molding - Scratch & Dent - Small / (R) Step, In-panel, Side Spoiler - Crack, Gap - Large / (R) Side Gate - Scratch & Dent - Large / Rear Bumper, Lamps, Panels - Scratch & Dent - Large / Rear Gate - Scratch & Dent - Large / Cab Back Panel - Crack, Gap - Small / (L) Side Gate - Scratch & Dent - Large / (L) Rear Door, Molding - Scratch - Minimal / (L) Front Door, Molding - Scratch - Minimal / (L) Step, In-panel, Side Spoiler - Scratch & Dent - Small / (L) Front Fender, Molding - Scratch - Minimal / Front Bumper, Grille, Lamps - Scratch & Dent - Large / Bonnet, Headlight - Scratch & Dent - Small / Roof - Scratch - Large |
