## General Information

| Make | Suzuki | Model | Ertiga |
| Registration No. | NNV1843 | Chassis No. | MHYNC32S4PJ100504 |

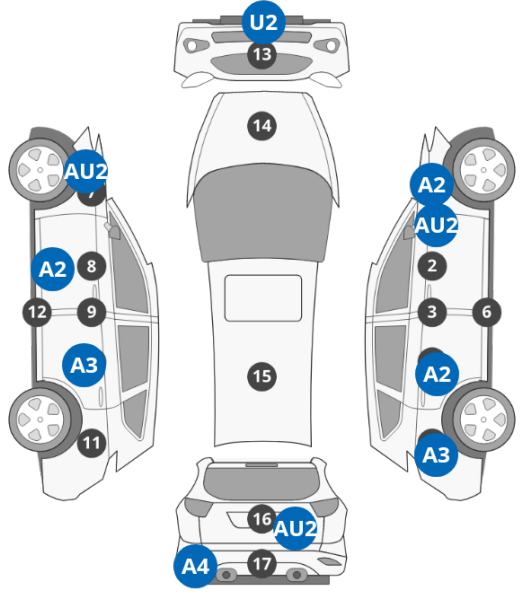
| Interior Evaluation : <span style="color: red; font-weight: bold;">A</span> | Exterior Evaluation : <span style="color: red; font-weight: bold;">C</span> |
| <b>Remarks</b><br>Defects not found | <b>Remarks</b><br>Trunk Hood, Rear Gate - Scratch & Dent - Small / (R) Rear Fender, Molding - Scratch - Medium / (R) Rear Door, Molding - Scratch - Small / (R) Front Door, Molding - Scratch & Dent - Small / (R) Front Fender, Molding - Scratch - Small / Front Bumper, Grille, Lamps - Dent - Small / (L) Front Fender, Molding - Scratch & Dent - Small / (L) Front Door, Molding - Scratch - Small / (L) Rear Door, Molding - Scratch - Medium / Rear Bumper, Lamps, Panels - Scratch - Large |
