## General Information

| Make | Hyundai | Model | H100 |
| Registration No. | NEA6788 | Chassis No. | KMFZBBX7BAHU489525 |

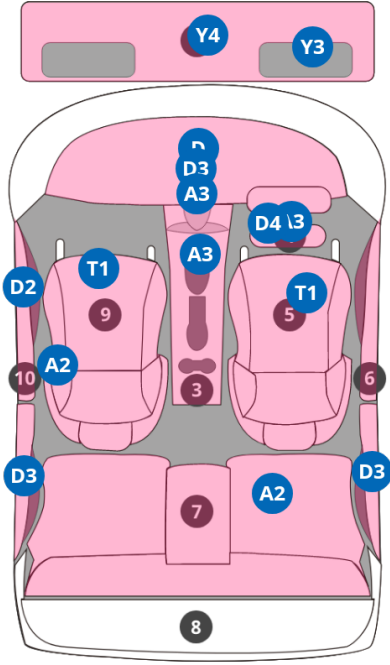
| Interior Evaluation : <b>E</b> | Exterior Evaluation : <b>E</b> |
| <p><b>Remarks</b></p> <p>Overall Interior - Worn as per age - Yes / Ceiling - Grime - Large / (R) Front Seat - Cigarette Burns - Burnt Minimal / (L) Front Seat - Cigarette Burns - Burnt Minimal / Dashboard - Traces of Adhesive Tape - Yes / Sunvisor, Sunglass Holder - Grime - Medium / (L) Front Floor Mat - Cut, Crack - Medium / Dashboard - Loose, Deformed - Medium / Steering Wheel - Worn, Peel, Crack - Medium / Carpet - Worked - Large / (L) Front Seat belt - Cut, Crack - Small / Console, Switches, Vents - Worn, Scratch, Cut, Crack - Medium / Rear Seat - Cut, Crack - Small / (L) Front Trim - Loose, Deformed - Small / Trim Other - Loose, Deformed - Medium</p> | <p><b>Remarks</b></p> <p>(R) Front Door - Repair Traces - Yes / (R) Front Fender - Repair Traces - Yes / Bonnet - Repair Traces - Yes / (L) Front Fender - Repair Traces - Yes / (L) Front Door - Repair Traces - Yes / (L) Rear Corner Panel - Repair Traces - Yes / Roof - Repair Traces - Yes / (R) Front Fender, Molding - Scratch &amp; Dent - Medium / (R) Mirror - Scratch - Small / (R) Front Door, Molding - Scratch &amp; Dent - Large / (R) Center Panel - Scratch - Small / (R) Step, In-panel, Side Spoiler - Scratch - Small / (R) Side Gate - Rust, Corrosion - Large / Rear Bumper, Lamps, Panels - Scratch &amp; Dent - Large / Rear Gate - Scratch - Large / Cargo Bed Floor - Rust, Corrosion - Large / Cab Back Panel - Scratch - Large / (L) Side Gate - Scratch &amp; Dent - Large / (L) Center Panel - Scratch - Medium / (L) Mirror - Scratch - Small / (L) Front Door, Molding - Scratch &amp; Dent - Large / Roof - Scratch &amp; Dent - Large / (L) Front Fender, Molding - Scratch - Small / Front Bumper, Grille, Lamps - Crack, Gap - Large / Bonnet, Headlight - Scratch - Small / Front Windshield - Damaged - Large / (L) Step, In-panel, Side Spoiler - Scratch - Small</p> |
