## General Information

| Make | Toyota | Model | Wigo |
| YOM | 2014 | Odo Meter Reading | 105,829 |
| Registration No. | AAP1346 | Chassis No. | MHKA4DF3F0J000561 |

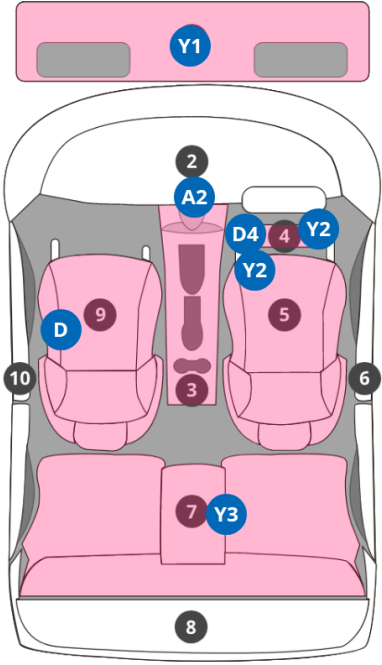
| Interior Evaluation : <span style="color: red;">C</span> | Exterior Evaluation : <span style="color: red;">E</span> |
| <b>Remarks</b><br>Rear Seat - Grime - Medium / (R) Front Seat - Grime - Small / (R) Front Floor Mat - Grime - Small / (L) Front Seat - Worn - Yes / (L) Front Floor Mat - Worked - Large / Ceiling - Grime - Minimal / Console, Switches, Vents - Worn, Scratch, Cut, Crack - Small / Overall Interior - Worn as per age - Yes | <b>Remarks</b><br>(R) Front Fender - Repair Traces - Yes / (L) Front Fender - Repair Traces - Yes / (R) Front Fender, Molding - Repair mark - Yes / (L) Mirror - Scratch - Minimal / (L) Front Fender, Molding - Scratch - Minimal / (L) Step, In-panel, Side Spoiler - Crack, Gap - Small / (L) Front Door, Molding - Scratch & Dent - Medium / (L) Rear Door, Molding - Scratch - Minimal / (L) Rear Fender, Molding - Scratch - Minimal / Trunk Hood, Rear Gate - Scratch - Minimal / Rear Bumper, Lamps, Panels - Scratch - Medium / (R) Rear Fender, Molding - Scratch - Small / (R) Step, In-panel, Side Spoiler - Scratch - Small / (R) Front Door, Molding - Scratch & Dent - Small / (R) Rear Door, Molding - Scratch - Small / (R) Mirror - Crack - Cracks / (R) Front Fender, Molding - Crack, Gap - Large / Front Bumper, Grille, Lamps - Modified - Medium / Front Bumper, Grille, Lamps - Scratch - Small / Bonnet, Headlight - Scratch - Minimal / Roof - Scratch - Minimal / Overall Exterior - Faded(Color, Gloss) - Yes / (R) Step, In-panel, Side Spoiler - Modified - Medium / (L) Step, In-panel, Side Spoiler - Modified - Medium / Rear Bumper, Lamps, Panels - Modified - Medium |
