## General Information

| Make | Toyota | Model | Camry |
| Registration No. | NCV4611 | Chassis No. | MK053AK50H9000545 |

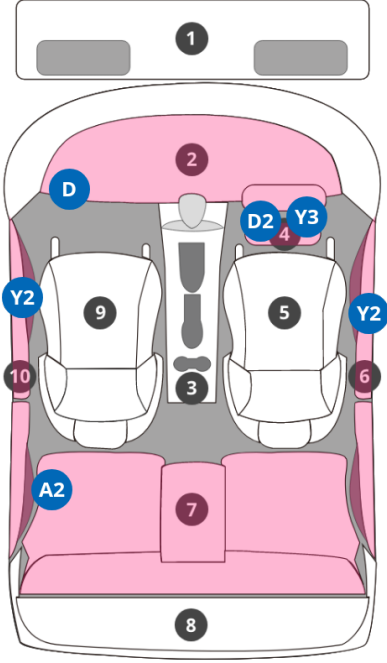
| Interior Evaluation : <b>C</b> | Exterior Evaluation : <b>D</b> |
| <p><b>Remarks</b></p> <p>(R) Front Trim - Grime - Small / (L) Front Trim - Grime - Small / (L) Front Floor Mat - Worked - Small / (R) Front Floor Mat - Grime - Medium / Rear Seat - Cut, Crack - Small / Dashboard - Traces of Adhesive Tape - Yes / Overall Interior - Worn as per age - Yes</p> | <p><b>Remarks</b></p> <p>Bonnet - Repair Traces - Yes / Trunk Hood, Rear Gate - Repair Traces - Yes / (R) Step, In-panel, Side Spoiler - Scratch &amp; Dent - Medium / (R) Rear Fender, Molding - Scratch - Small / Rear Bumper, Lamps, Panels - Repair mark - Yes / Rear Bumper, Lamps, Panels - Scratch &amp; Dent - Medium / Trunk Hood, Rear Gate - Scratch - Small / (L) Rear Fender, Molding - Scratch - Minimal / (L) Rear Door, Molding - Scratch - Small / (L) Step, In-panel, Side Spoiler - Scratch - Small / (L) Front Fender, Molding - Scratch - Small / (L) Mirror - Scratch - Minimal / Member (Bolted) - Dent - Yes / Front Bumper, Grille, Lamps - Repair mark - Yes / Front Bumper, Grille, Lamps - Scratch - Large / Bonnet, Headlight - Scratch - Small / Roof - Dent - Medium / (L) Front Door, Molding - Scratch - Minimal / (R) Front Door, Molding - Scratch - Minimal</p> |
