## General Information

| Make | Toyota | Model | Wigo |
| YOM | 2022 | Odo Meter Reading | 80,677 |
| Registration No. | FAJ6075 | Chassis No. | MHKA4DF5FNJ069966 |

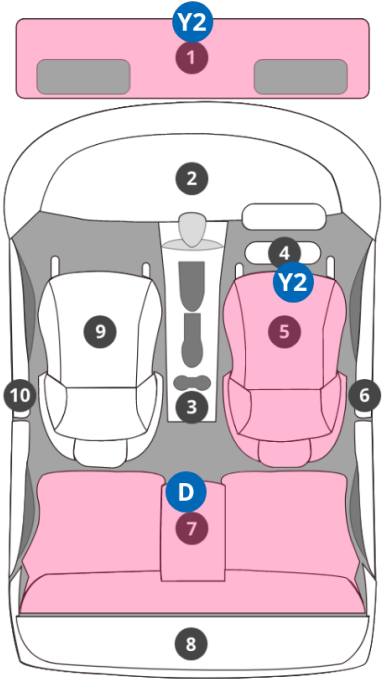
| Interior Evaluation : <b>B</b> | Exterior Evaluation : <b>E</b> |
|---|---|
| <b>Remarks</b><br>Ceiling - Grime - Small / (R) Front Seat - Grime - Small / Rear Seat - Worn - Yes | <b>Remarks</b><br>(R) Front Door - Repair Traces - Yes / (R) Front Fender - Repair Traces - Yes / Bonnet - Repair Traces - Yes / (L) Front Fender - Repair Traces - Yes / (L) Front Door - Repair Traces - Yes / (L) Rear Door - Repair Traces - Yes / (L) Rear Fender - Repair Traces - Yes / Trunk Hood, Rear Gate - Repair Traces - Yes / (R) Rear Fender - Repair Traces - Yes / (R) Rear Door - Repair Traces - Yes / Roof - Repair Traces - Yes / (R) Front Fender, Molding - Repair mark - Yes / (R) Front Fender, Molding - Crack, Gap - Small / (R) Front Door, Molding - Repair mark - Yes / (R) Rear Door, Molding - Repair mark - Yes / (R) Front Door, Molding - Dent - Small / (R) Step, In-panel, Side Spoiler - Scratch - Large / (R) Rear Fender, Molding - Repair mark - Yes / (R) Rear Fender, Molding - Scratch - Minimal / Rear Bumper, Lamps, Panels - Repair mark - Yes / Trunk Hood, Rear Gate - Scratch & Dent - Medium / (L) Front Fender, Molding - Repair mark - Yes / (L) Front Door, Molding - Dent - Medium / (L) Mirror - Crack - Cracks / Bonnet, Headlight - Repair mark - Yes / Front Bumper, Grille, Lamps - Repair mark - Yes |
