## General Information

| Make | Suzuki | Model | Ertiga |
| Registration No. | FNV2217 | Chassis No. | MHYNC32S6TJ101938 |

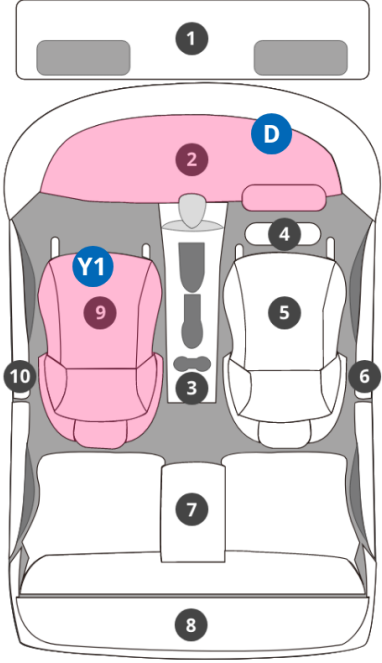
| Interior Evaluation : <b>A</b> | Exterior Evaluation : <b>C</b> |
| <b>Remarks</b><br>(L) Front Seat - Grime - Minimal / Dashboard - Traces of Adhesive Tape - Yes | <b>Remarks</b><br>(R) Rear Door, Molding - Dent - Minimal / Front Bumper, Grille, Lamps - Scratch - Large |
