## General Information

| Make | Toyota | Model | Alphard |
| Registration No. | NDI1754 | Chassis No. | JTNGZ3DH6K6050892 |

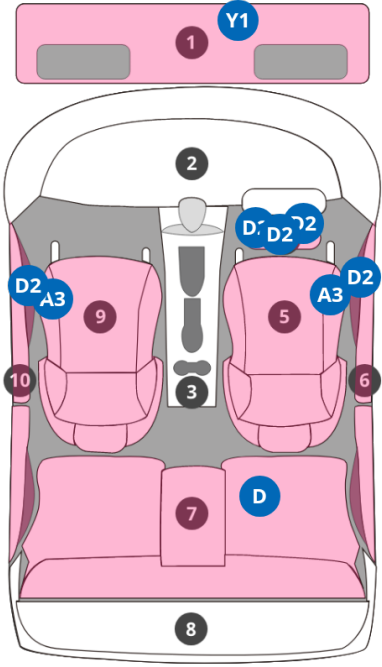
| Interior Evaluation : <span>C</span> | Exterior Evaluation : <span>C</span> |
| <b>Remarks</b><br>(L) Front Floor Mat - Worked - Small / (R) Front Floor Mat - Worked - Small / (L) Front Seat - Cut, Crack - Medium / (R) Front Seat - Cut, Crack - Medium / Rear Seat - Worn - Yes / (L) Front Trim - Worked - Small / (R) Front Trim - Worked - Small / Mat Other - Worked - Small / Ceiling - Grime - Minimal | <b>Remarks</b><br>Trunk Hood, Rear Gate - Repair Traces - Yes / Front Bumper, Grille, Lamps - Scratch - Large / (R) Front Fender, Molding - Dent - Minimal / (R) Front Door, Molding - Scratch - Minimal / (R) Rear Door, Molding - Scratch - Small / (R) Step, In-panel, Side Spoiler - Scratch - Medium / Rear Bumper, Lamps, Panels - Scratch - Large / (L) Rear Fender, Molding - Scratch - Minimal / (L) Rear Door, Molding - Scratch - Small / (L) Step, In-panel, Side Spoiler - Scratch - Minimal / (L) Front Door, Molding - Scratch - Small / (L) Front Fender, Molding - Scratch - Minimal / Overall Exterior - Faded(Color, Gloss) - Yes / Roof - Scratch - Minimal |
