## General Information

| Make | Toyota | Model | Vios |
| YOM | 2024 | Mileage | 10,271 |
| Registration No. | DBN7717 | Chassis No. | PA1B18F30P4233308 |

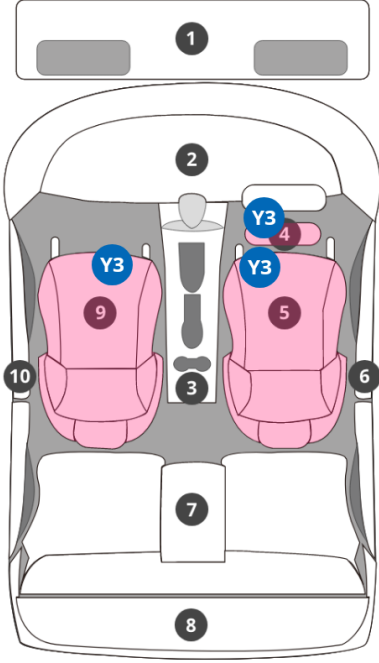
| Interior Evaluation : <b>B</b> | Exterior Evaluation : <b>D</b> |
|---|---|
| <b>Remarks</b><br>(R) Front Seat - Grime - Medium / (L) Front Seat - Grime - Medium / (L) Front Floor Mat - Grime - Medium | <b>Remarks</b><br>Member (Bolted) - Dent - Yes / Front Bumper, Grille, Lamps - Scratch & Dent - Large / (R) Front Fender, Molding - Scratch & Dent - Minimal / Rear Bumper, Lamps, Panels - Scratch - Large / (L) Rear Door, Molding - Scratch - Medium / (R) Rear Fender, Molding - Scratch - Minimal / (R) Rear Door, Molding - Scratch - Small / (L) Front Door, Molding - Scratch - Small / (R) Front Door, Molding - Scratch - Medium / Bonnet, Headlight - Scratch & Dent - Large |

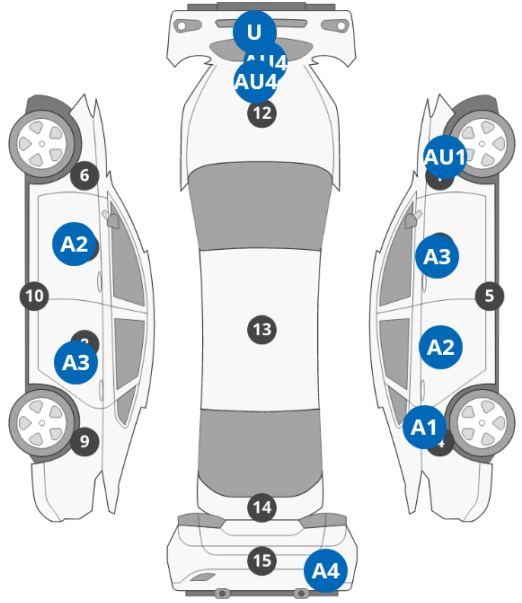
| Inspector Notes |
|---|
| with warranty booklet, spare tire, jack but incomplete tools. with LTO plate. Gap at front bumper. |
