## General Information

| Make | Nissan | Model | NV350 |
| Registration No. | NFZ1156 | Chassis No. | JN1TC2E26Z0061895 |

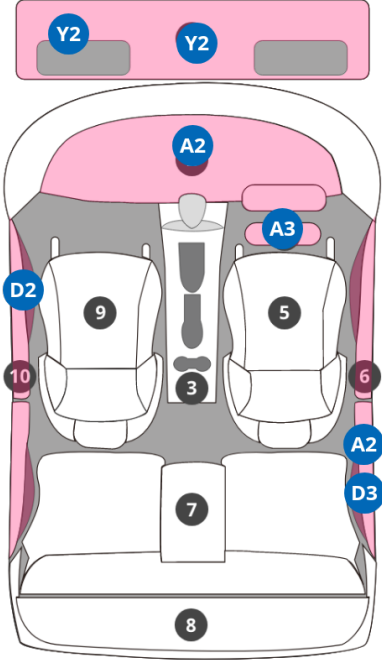
| Interior Evaluation : <b>B</b> | Exterior Evaluation : <b>E</b> |
| <p><b>Remarks</b></p> <p>(R) Rear Trim - Cut, Crack - Small / Trim Other - Loose, Deformed - Medium / Sunvisor, Sunglass Holder - Grime - Small / Ceiling - Grime - Small / Carpet - Worn, Scratch, Cut, Crack - Medium / Dashboard - Worn, Scratch, Cut, Crack - Small / (L) Front Trim - Worked - Small</p> | <p><b>Remarks</b></p> <p>(R) Rear Fender - Repair Traces - Yes / (R) Rear Door - Repair Traces - Yes / (R) Front Fender, Molding - Scratch - Minimal / (R) Mirror - Scratch - Small / (R) Front Door, Molding - Scratch &amp; Dent - Small / (R) Center Panel - Scratch &amp; Dent - Minimal / (R) Rear Door, Molding - Repair mark - Yes / (R) Rear Door, Molding - Scratch &amp; Dent - Large / (R) Step, In-panel, Side Spoiler - Scratch - Small / (R) Rear Fender, Molding - Scratch &amp; Dent - Medium / Roof - Scratch &amp; Dent - Large / Rear Bumper, Lamps, Panels - Crack, Gap - Large / (R) Rear Fender, Molding - Repair mark - Yes / Trunk Hood, Rear Gate - Scratch &amp; Dent - Small / (L) Rear Fender, Molding - Repair mark - Yes / (L) Rear Fender, Molding - Scratch &amp; Dent - Medium / (L) Front Door, Molding - Scratch &amp; Dent - Small / (L) Mirror - Scratch - Minimal / (L) Step, In-panel, Side Spoiler - Scratch - Small / Front Bumper, Grille, Lamps - Scratch &amp; Dent - Large / Front Panel - Scratch &amp; Dent - Minimal / Front Windshield - Scratch, Stone chip - Small</p> |
