## General Information

| Make | Isuzu | Model | Traviz |
| Registration No. | EAI8740 | Chassis No. | MHCPHR54DPJ530404 |

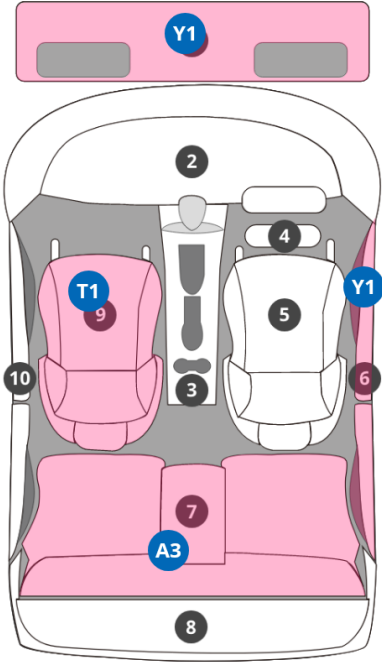
| Interior Evaluation : <b>B</b> | Exterior Evaluation : <b>C</b> |
|---|---|
| <b>Remarks</b><br>Ceiling - Grime - Minimal / (R) Front Trim - Grime - Minimal / (L) Front Seat - Cigarette Burns - Burnt Minimal / Rear Seat - Cut, Crack - Medium | <b>Remarks</b><br>(L) Rear Corner Panel - Repair Traces - Yes / (R) Rear Corner Panel - Repair Traces - Yes / Roof - Repair Traces - Yes / (R) Front Fender, Molding - Scratch - Minimal / (R) Mirror - Scratch - Minimal / (R) Front Door, Molding - Scratch - Minimal / (R) Step, In-panel, Side Spoiler - Scratch - Small / Roof - Dent - Large / (R) Side Gate - Scratch - Small / Rear Bumper, Lamps, Panels - Scratch - Small / Rear Gate - Scratch - Minimal / (L) Side Gate - Scratch - Small / (L) Front Door, Molding - Scratch - Medium / (L) Mirror - Faded(Color, Gloss) - Yes / Antennae - Damaged - Yes / Front Bumper, Grille, Lamps - Scratch - Minimal / (L) Step, In-panel, Side Spoiler - Scratch - Small |
