## General Information

| Make | Toyota | Model | Vios |
| YOM | 2017 | Mileage | 160,999 |
| Registration No. | NCN2466 | Chassis No. | PA1B18F36H4019375 |

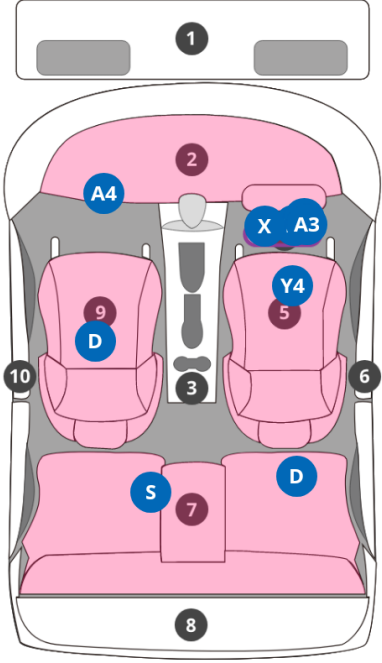
| Interior Evaluation : <span style="color: red;">C</span> | Exterior Evaluation : <span style="color: red;">C</span> |
|---|---|
| <p><b>Remarks</b></p> <p>Rear Seat - Worn - Yes / Mat Other - Grime - Large / (R) Front Seat - Grime - Large / (L) Front Floor Mat - Missing - Yes / (R) Front Floor Mat - Missing - Yes / Carpet - Worn, Scratch, Cut, Crack - Medium / (L) Front Seat - Worn - Yes / Overall Interior - Worn as per age - Yes / Overall Interior - Smell - Yes / Steering Wheel - Worn, Peel, Crack - Large</p> | <p><b>Remarks</b></p> <p>(R) Front Door - Repair Traces - Yes / (R) Step - Repair Traces - Yes / (R) Front Fender - Repair Traces - Yes / Bonnet - Repair Traces - Yes / (L) Front Fender - Repair Traces - Yes / (L) Front Door - Repair Traces - Yes / (L) Step - Repair Traces - Yes / (L) Rear Door - Repair Traces - Yes / (L) Rear Fender - Repair Traces - Yes / Trunk Hood, Rear Gate - Repair Traces - Yes / (R) Rear Fender - Repair Traces - Yes / (R) Rear Door - Repair Traces - Yes / Roof - Repair Traces - Yes / Front Bumper, Grille, Lamps - Crack, Gap - Large / (L) Step, In-panel, Side Spoiler - Repair mark - Yes / Front Bumper, Grille, Lamps - Repair mark - Yes / Rear Bumper, Lamps, Panels - Repair mark - Yes / (R) Step, In-panel, Side Spoiler - Repair mark - Yes / Roof - Dent - Large / Rear Bumper, Lamps, Panels - Crack, Gap - Large / (R) Rear Door, Molding - Dent - Small</p> |
