## General Information

| Make | Ford | Model | EcoSport |
| YOM | 2017 | Mileage | 80,906 |
| Registration No. | DAD6123 | Chassis No. | MPBSXXMXKSHJ69608 |

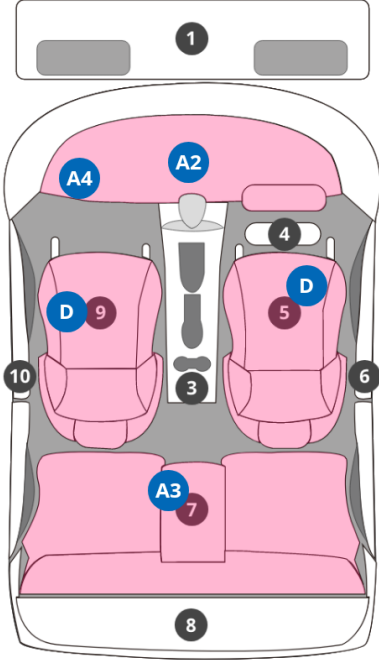
| Interior Evaluation : <b>C</b> | Exterior Evaluation : <b>B</b> |
|---|---|
| <p><b>Remarks</b></p> <p>Rear Seat - Cut, Crack - Medium / (L) Front Seat - Worn - Yes / (R) Front Seat - Worn - Yes / Dashboard - Worn, Scratch, Cut, Crack - Small / Overall Interior - Worn as per age - Yes / Steering Wheel - Worn, Peel, Crack - Large</p> | <p><b>Remarks</b></p> <p>(R) Front Fender - Repair Traces - Yes / (L) Rear Fender, Molding - Scratch &amp; Dent - Small / (R) Front Door, Molding - Scratch &amp; Dent - Medium / Front Bumper, Grille, Lamps - Scratch - Small / (L) Front Fender, Molding - Scratch &amp; Dent - Minimal / (L) Rear Door, Molding - Dent - Minimal / Trunk Hood, Rear Gate - Scratch - Medium / Roof - Dent - Small</p> |
