## General Information

| Make | Isuzu | Model | D-MAX |
| Registration No. | ZSP136 | Chassis No. | MPATFR54H6H589972 |

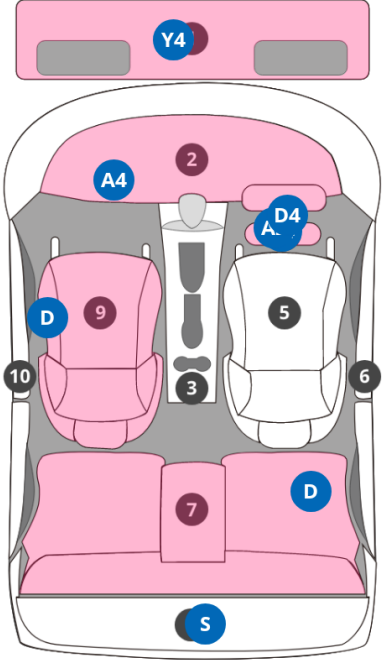
| Interior Evaluation : <b>D</b> | Exterior Evaluation : <b>E</b> |
| <p><b>Remarks</b></p> <p>Overall Interior - Worn as per age - Yes / (R) Front Floor Mat - Worked - Large / (R) Front Floor Mat - Cut, Crack - Small / Carpet - Loose, Deformed - Large / Ceiling - Grime - Large / Rear Seat - Worn - Yes / Steering Wheel - Worn, Peel, Crack - Large / (L) Front Seat - Worn - Yes / Overall Interior - Smell - Yes</p> | <p><b>Remarks</b></p> <p>(R) Front Fender - Repair Traces - Yes / (L) Front Door - Repair Traces - Yes / (L) Rear Corner Panel - Repair Traces - Yes / Roof - Repair Traces - Yes / (R) Mirror - Scratch - Minimal / (R) Front Fender, Molding - Dent - Small / Cargo Bed Floor - Rust, Corrosion - Large / Rear Gate - Scratch - Medium / Rear Bumper, Lamps, Panels - Rust, Corrosion - Large / (R) Side Gate - Repair mark - Yes / (L) Side Gate - Repair mark - Yes / Roof - Rust, Corrosion - Large / (L) Front Door, Molding - Scratch &amp; Dent - Small / (L) Front Fender, Molding - Scratch &amp; Dent - Small / Bonnet, Headlight - Dent - Large / Front Bumper, Grille, Lamps - Scratch - Small / (R) Side Gate - Dent - Large / (R) Front Door, Molding - Scratch &amp; Dent - Minimal / Cab Back Panel - Rust, Corrosion - Large / Front Windshield - Scratch, Stone chip - Small</p> |

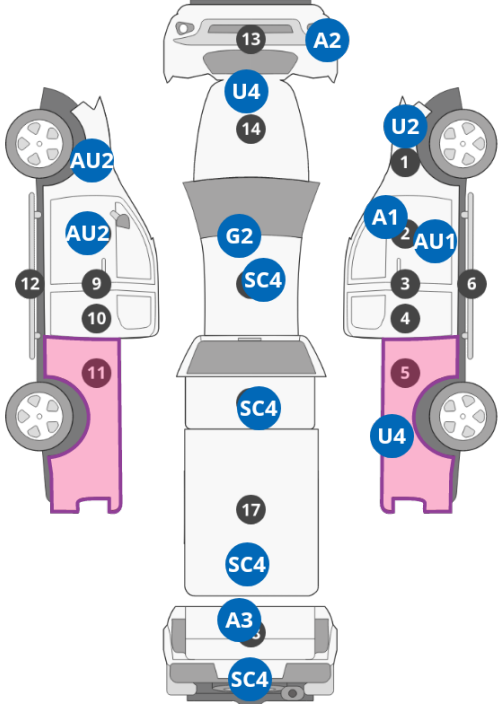
| Inspector Notes |
|---|
| <p>with warranty booklet, with jack and tools, with spare tire, with LTO plate, right brake lights issue, crack on rear left signal light, air-conditioning issue, manual window issue</p> |
