## General Information

| Make | Suzuki | Model | Ertiga |

## Body / Panel Condition

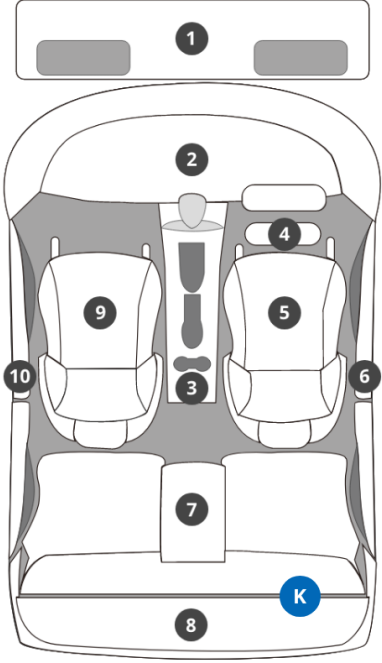
| Interior Evaluation : <b>B</b> | Exterior Evaluation : <b>C</b> |
| <b>Remarks</b><br>Overall Interior - Animal Hair - Yes | <b>Remarks</b><br>(L) Rear Door, Molding - Scratch & Dent - Large / Front Bumper, Grille, Lamps - Scratch & Dent - Medium / (R) Rear Door, Molding - Scratch - Small / (R) Step, In-panel, Side Spoiler - Scratch - Small / (R) Front Door, Molding - Scratch - Small / Rear Bumper, Lamps, Panels - Scratch - Medium / Roof - Dent - Small |
