## General Information

| Make | Toyota | Model | Rush |
| YOM | 2022 | Mileage | 44,734 |
| Registration No. | DAR3790 | Chassis No. | MHKE8FF3PNK044903 |

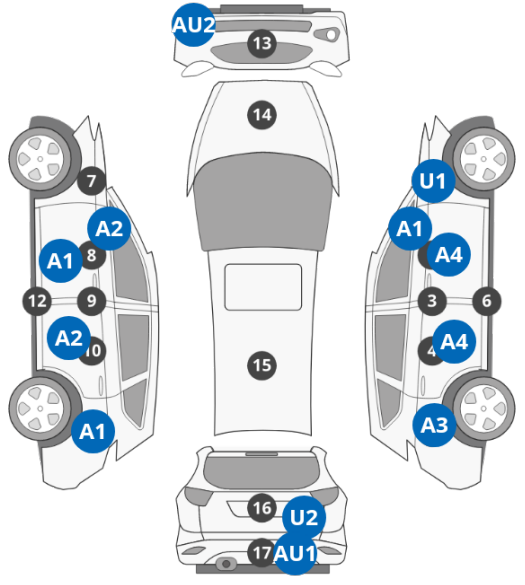
| <b>Remarks</b><br>Steering Wheel - Worn, Peel, Crack - Small / Trunk Room - Loose, Deformed, Grime - Medium / Rear Seat - Grime - Small | <b>Remarks</b><br>Front Bumper, Grille, Lamps - Scratch & Dent - Small / (L) Mirror - Scratch - Small / (L) Front Door, Molding - Scratch - Minimal / (L) Rear Door, Molding - Scratch - Small / (L) Rear Fender, Molding - Scratch - Minimal / Trunk Hood, Rear Gate - Dent - Small / Rear Bumper, Lamps, Panels - Scratch & Dent - Minimal / (R) Rear Fender, Molding - Scratch - Medium / (R) Rear Door, Molding - Scratch - Large / (R) Front Door, Molding - Scratch - Large / (R) Mirror - Scratch - Minimal / (R) Front Fender, Molding - Dent - Minimal |

| Inspector Notes |
|---|
| radio not working. reverse camera not working. more scratches and dent around the exterior. |
