## General Information

<b>Make</b>	Toyota	<b>Model</b>	Vios
<b>YOM</b>	2023	<b>Mileage</b>	31,521
<b>Registration No.</b>	NHI8203	<b>Chassis No.</b>	PA1B18F34P4212638
<b>CC</b>	1.3	<b>Transmission</b>	CVT
<b>Fuel Type</b>	Gas	<b>Type of Body</b>	Sedan
<b>Colour</b>	Silver

## Body / Panel Condition

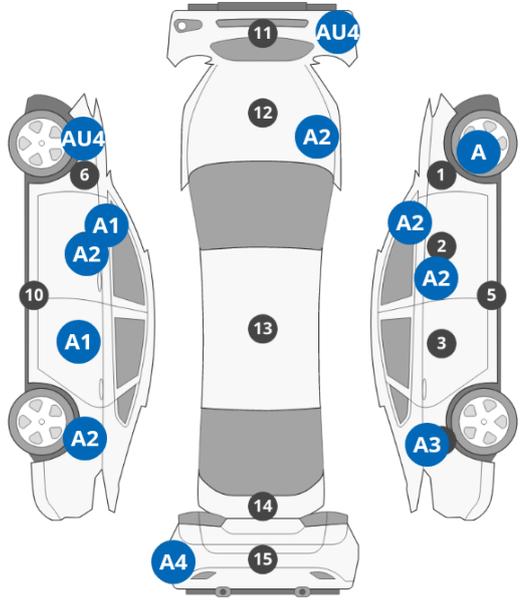
<p><b>A</b> : Scratch <b>AU</b> : Scratch &amp; Dent <b>B</b> : Modified <b>C</b> : Corrosion <b>G</b> : Stone chip <b>P</b> : Faded <b>S</b> : Rust <b>SC</b> : Rust &amp; Corrosion <b>U</b> : Dent <b>X</b> : Defective <b>Y</b> : Crack, Gap</p>
<p><b>Remarks</b> Dashboard - Traces of Adhesive Tape - Yes / (R) Front Seat - Grime - Medium / Rear Seat - Grime - Medium / (L) Front Floor Mat - Worked - Small / (L) Front Seat - Grime - Small</p>	<p><b>Remarks</b> (L) Front Fender, Molding - Scratch &amp; Dent - Large / Front Bumper, Grille, Lamps - Scratch &amp; Dent - Large / (R) Rear Fender, Molding - Scratch - Medium / (R) Mirror - Scratch - Small / (L) Mirror - Scratch - Minimal / Bonnet, Headlight - Scratch - Small / (R) Front Door, Molding - Scratch - Small / Rear Bumper, Lamps, Panels - Scratch - Large / (L) Front Door, Molding - Scratch - Small / (L) Rear Door, Molding - Scratch - Minimal / (L) Rear Fender, Molding - Scratch - Small / (R) Front Tyre - Crack, Cut - Yes</p>
