General Information

Make	Toyota	Model	Hiace
YOM	2015	Mileage	89,991
Registration No.	ABL5958	Chassis No.	JS02P280049698
CC	2.5	Transmission	M/T
Fuel Type	Diesel	Type of Body	Van
Colour	White

Body / Panel Condition

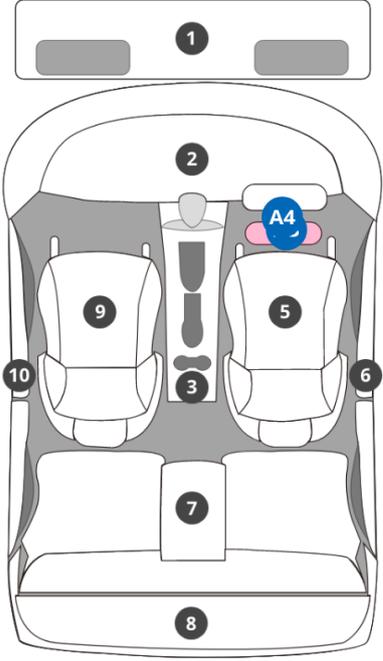
<p>a : Cut, Fray d : Loose, Deformed k : Animal Hair s : Smell t : Cigarette Burns x : Defective y : Stain</p>

<p>A : Scratch AU : Scratch & Dent B : Modified C : Corrosion G : Stone chip P : Faded S : Rust SC : Rust & Corrosion U : Dent X : Defective Y : Crack, Gap</p>
<p>Remarks Carpet - Worn, Scratch, Cut, Crack - Medium / (L) Front Floor Mat - Cut, Crack - Large / Overall Interior - Worn as per age - Yes</p>	<p>Remarks (R) Front Door - Repair Traces - Yes / (R) Step - Repair Traces - Yes / Front Panel - Repair Traces - Yes / (L) Front Door - Repair Traces - Yes / (L) Step - Repair Traces - Yes / (L) Rear Fender - Repair Traces - Yes / Trunk Hood, Rear Gate - Repair Traces - Yes / (R) Rear Fender - Repair Traces - Yes / (R) Rear Door - Repair Traces - Yes / (R) Center Panel - Repair Traces - Yes / Roof - Repair Traces - Yes / Rear Bumper, Lamps, Panels - Scratch & Dent - Large / (L) Rear Door, Molding - Dent - Small / (R) Rear Door, Molding - Scratch - Small / Front Bumper, Grille, Lamps - Scratch & Dent - Medium / (L) Front Wheel, Cover - Cap Missing - Yes / (L) Rear Wheel, Cover - Cap Missing - Yes / (R) Front Wheel, Cover - Cap Missing - Yes / (R) Rear Wheel, Cover - Cap Missing - Yes</p>
