## General Information

| Make | Toyota | Model | Vios |
| YOM | 2023 | Mileage | 20,981 |
| Registration No. | NHI2724 | Chassis No. | PA1B18F31P4204710 |

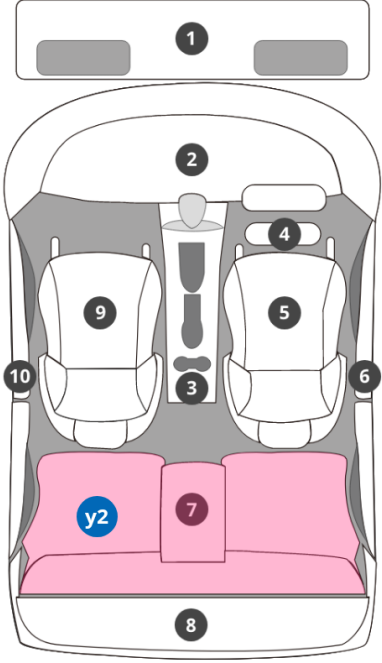
| Interior Evaluation : <span style="color: red; font-weight: bold;">A</span> | Exterior Evaluation : <span style="color: red; font-weight: bold;">C</span> |
| <b>Remarks</b><br>Defects not found | <b>Remarks</b><br>(L) Rear Fender, Molding - Scratch & Dent - Large / Rear Bumper, Lamps, Panels - Scratch & Dent - Medium / (R) Front Door, Molding - Scratch - Small / (R) Front Fender, Molding - Scratch - Small / Front Bumper, Grille, Lamps - Scratch - Small / Bonnet, Headlight - Scratch - Small / (L) Rear Door, Molding - Scratch & Dent - Minimal / (R) Mirror - Scratch - Minimal |

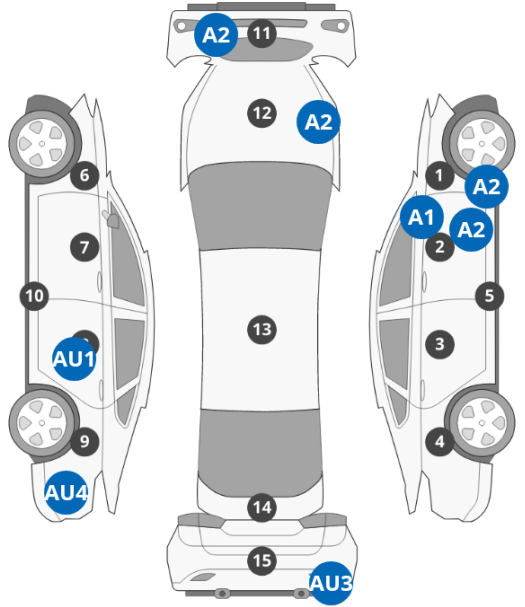
adhesive marks at the right side front and rear doors and at the side mirror. more light scratches around the exterior. rear seats has molds.
