## General Information

<b>Make</b>	Toyota	<b>Model</b>	Vios
<b>YOM</b>	2023	<b>Mileage</b>	51,063
<b>Registration No.</b>	DBB5480	<b>Chassis No.</b>	PA1B18F37N4196173
<b>CC</b>	1.3	<b>Transmission</b>	CVT
<b>Fuel Type</b>	Gas	<b>Type of Body</b>	Sedan
<b>Colour</b>	Green

## Body / Panel Condition

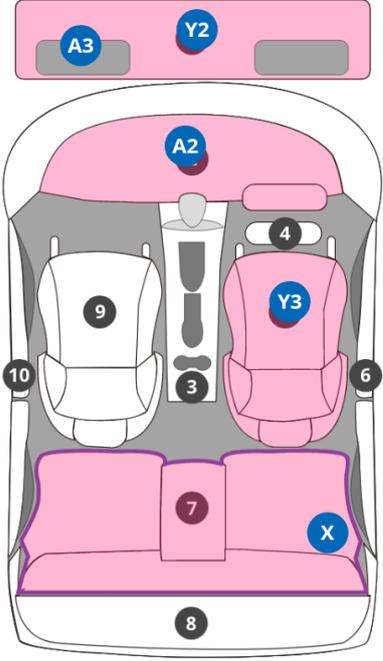
<b>Interior Evaluation :</b> <span style="color: red; font-weight: bold; font-size: 1.2em;">C</span>	<b>Exterior Evaluation :</b> <span style="color: red; font-weight: bold; font-size: 1.2em;">C</span>

<p><b>a</b> : Cut, Fray <b>d</b> : Loose, Deformed <b>k</b> : Animal Hair <b>s</b> : Smell <b>t</b> : Cigarette Burns <b>x</b> : Defective <b>y</b> : Stain</p>

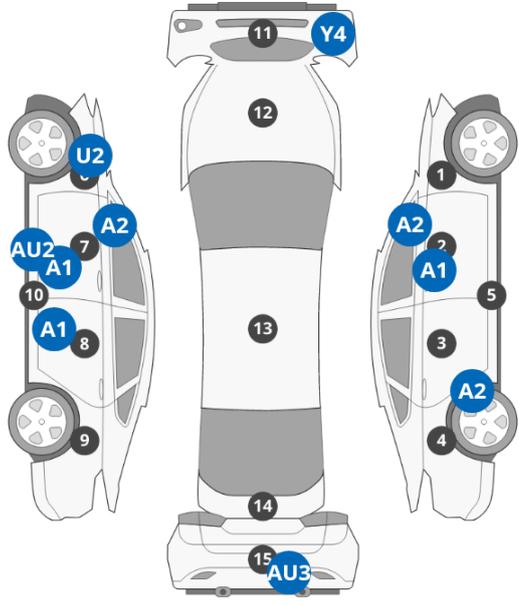
<p><b>A</b> : Scratch <b>AU</b> : Scratch &amp; Dent <b>B</b> : Modified <b>C</b> : Corrosion <b>G</b> : Stone chip <b>P</b> : Faded <b>S</b> : Rust <b>SC</b> : Rust &amp; Corrosion <b>U</b> : Dent <b>X</b> : Defective <b>Y</b> : Crack, Gap</p>
<p><b>Remarks</b> (R) Front Seat - Grime - Medium / Dashboard - Worn, Scratch, Cut, Crack - Small / Ceiling - Grime - Small / Sunvisor, Sunglass Holder - Cut, Crack - Medium / Rear Seat - Partially Missing - Yes</p>	<p><b>Remarks</b> (R) Front Fender - Repair Traces - Yes / Bonnet - Repair Traces - Yes / (L) Front Fender - Repair Traces - Yes / Rear Bumper, Lamps, Panels - Scratch &amp; Dent - Medium / (L) Mirror - Scratch - Small / (L) Front Door, Molding - Scratch - Minimal / (L) Rear Door, Molding - Scratch - Minimal / (L) Front Fender, Molding - Dent - Small / Front Bumper, Grille, Lamps - Crack, Gap - Large / (R) Mirror - Scratch - Small / (R) Front Door, Molding - Scratch - Minimal / (R) Rear Fender, Molding - Scratch - Small / (L) Step, In-panel, Side Spoiler - Scratch &amp; Dent - Small</p>
