## General Information

Date & Time: 31, Mar, 2025 12:30

<b>Make</b>	Toyota	<b>Model</b>	Vios
<b>YOM</b>	2024	<b>Mileage</b>	13,963
<b>Registration No.</b>	DBM7904	<b>Chassis No.</b>	PA1B18F39R4246253
<b>CC</b>	1.3	<b>Transmission</b>	CVT
<b>Fuel Type</b>	Gas	<b>Type of Body</b>	Sedan
<b>Colour</b>	Red

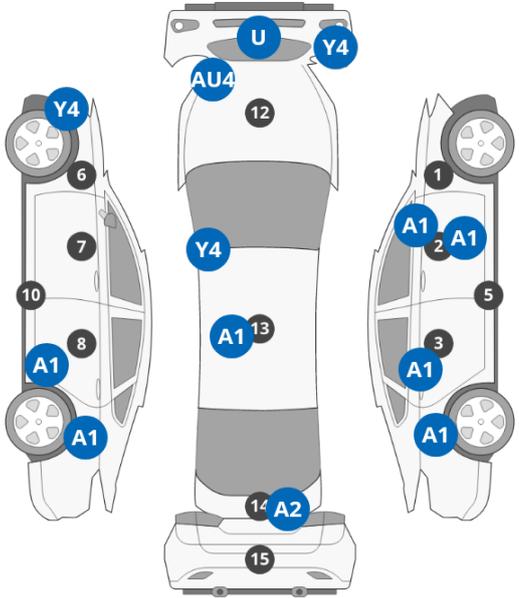
<p><b>A</b> : Scratch <b>AU</b> : Scratch &amp; Dent <b>B</b> : Modified <b>C</b> : Corrosion <b>G</b> : Stone chip <b>P</b> : Faded <b>S</b> : Rust <b>SC</b> : Rust &amp; Corrosion <b>U</b> : Dent <b>X</b> : Defective <b>Y</b> : Crack, Gap</p>
<p><b>Remarks</b> Rear Seat - Grime - Minimal / (L) Front Trim - Grime - Minimal</p>	<p><b>Remarks</b> (L) Rear Fender - Repair Traces - Yes / Front Windshield - Damaged - Large / Bonnet, Headlight - Scratch &amp; Dent - Large / Member (Bolted) - Dent - Yes / (R) Mirror - Scratch - Minimal / (R) Front Door, Molding - Scratch - Minimal / (R) Rear Door, Molding - Scratch - Minimal / (R) Rear Fender, Molding - Scratch - Minimal / Trunk Hood, Rear Gate - Scratch - Small / (L) Rear Fender, Molding - Scratch - Minimal / (L) Rear Door, Molding - Scratch - Minimal / Roof - Scratch - Minimal / Front Bumper, Grille, Lamps - Crack, Gap - Large / (L) Front Fender, Molding - Crack, Gap - Large</p>
