## General Information

| Make | Toyota | Model | Avanza |
| YOM | 2024 | Mileage | 12,994 |
| Registration No. | DBO4879 | Chassis No. | MHFAA1BY6P0020486 |

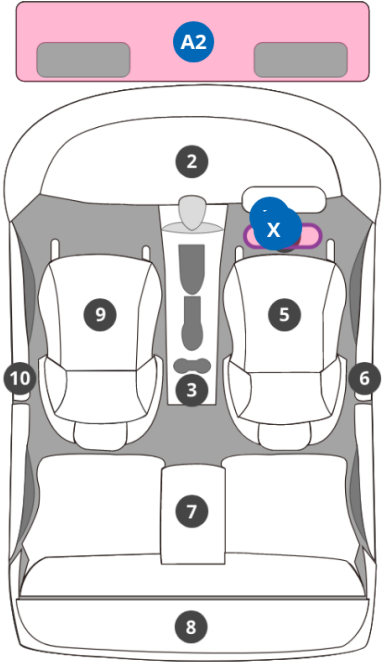
| Interior Evaluation : <b>B</b> | Exterior Evaluation : <b>C</b> |
| <b>Remarks</b><br>(L) Front Floor Mat - Missing - Yes / (R) Front Floor Mat - Missing - Yes / Mat Other - Missing - Yes / Ceiling - Cut, Crack - Small | <b>Remarks</b><br>(R) Mirror - Scratch - Minimal / (R) Rear Door, Molding - Scratch & Dent - Medium / (R) Rear Fender, Molding - Scratch - Small / Rear Bumper, Lamps, Panels - Scratch - Large / (L) Rear Fender, Molding - Scratch - Small / (L) Rear Door, Molding - Scratch - Small / (L) Front Fender, Molding - Scratch - Small / Front Bumper, Grille, Lamps - Scratch & Dent - Large / Member (Bolted) - Dent - Yes / Bonnet, Headlight - Dent - Small |

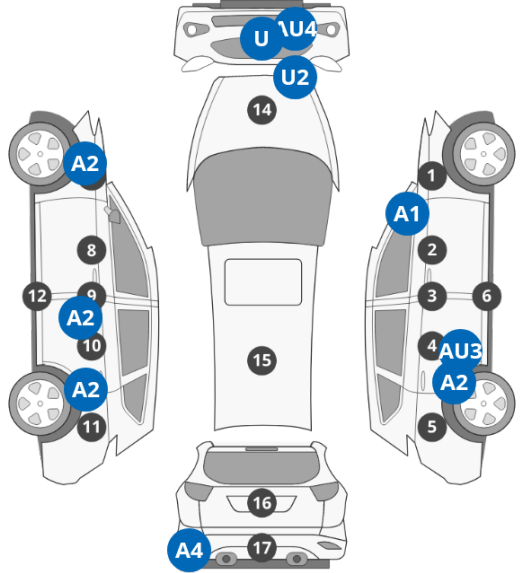
| Interior Evaluation : <b>B</b> | Exterior Evaluation : <b>C</b> |
|---|---|
| <b>Remarks</b><br>Front Cross Member Support - Traces of Bending, or Marks of Panel Repair ? - Yes | <b>Remarks</b><br>Defects not found |
