General Information

| Make | Toyota | Model | Vios |
| Registration No. | DAQ9683 | Chassis No. | PA1B18F32N4179166 |

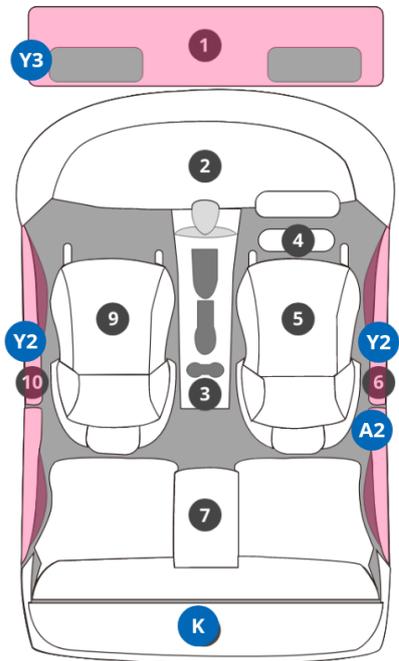
| Interior Evaluation : B | Exterior Evaluation : D |
| Remarks (R) Rear Trim - Cut, Crack - Small / Overall Interior - Animal Hair - Yes / (R) Front Trim - Grime - Small / (L) Front Trim - Grime - Small / Ceiling - Grime - Medium | Remarks (R) Front Fender - Repair Traces - Yes / (L) Rear Door - Repair Traces - Yes / (L) Rear Fender - Repair Traces - Yes / (R) Front Door, Molding - Repair mark - Yes / (R) Step, In-panel, Side Spoiler - Scratch & Dent - Large / (R) Front Door, Molding - Dent - Small / (R) Rear Fender, Molding - Dent - Minimal / Rear Bumper, Lamps, Panels - Scratch - Small / Trunk Hood, Rear Gate - Dent - Small / (L) Rear Fender, Molding - Scratch & Dent - Small / (L) Front Door, Molding - Scratch & Dent - Small / (L) Rear Door, Molding - Dent - Large / Front Bumper, Grille, Lamps - Scratch & Dent - Medium / Bonnet, Headlight - Scratch & Dent - Small |
