## General Information

| Make | Toyota | Model | Avanza |
| Registration No. | NHS4911 | Chassis No. | MHFAA1BY0R0027274 |

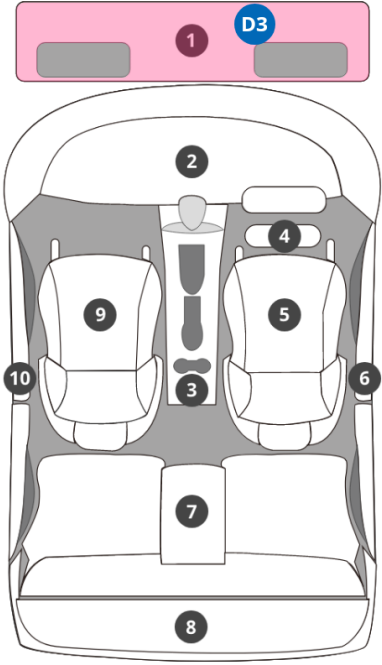
| Interior Evaluation : <b>B</b> | Exterior Evaluation : <b>D</b> |
| <b>Remarks</b><br>Ceiling - Crinkle - Medium | <b>Remarks</b><br>Front Bumper, Grille, Lamps - Scratch - Large / (R) Front Door, Molding - Scratch & Dent - Small / (R) Step, In-panel, Side Spoiler - Scratch - Medium / (R) Rear Door, Molding - Scratch & Dent - Small / Rear Bumper, Lamps, Panels - Repair mark - Yes / (R) Rear Fender, Molding - Scratch & Dent - Small / Trunk Hood, Rear Gate - Scratch - Small / (L) Rear Fender, Molding - Scratch - Minimal / (L) Step, In-panel, Side Spoiler - Dent - Small / Front Bumper, Grille, Lamps - Repair mark - Yes / (L) Rear Door, Molding - Scratch & Dent - Small / (L) Front Door, Molding - Scratch - Minimal / (L) Front Fender, Molding - Scratch - Minimal / Roof - Scratch - Large / Bonnet, Headlight - Scratch - Small |
