## General Information

<b>Make</b>	Toyota	<b>Model</b>	Vios
<b>YOM</b>	2024	<b>Mileage</b>	11,300
<b>Registration No.</b>	BAG2725	<b>Chassis No.</b>	PA1B18F31R4248631
<b>CC</b>	1.3	<b>Transmission</b>	CVT
<b>Fuel Type</b>	Gas	<b>Type of Body</b>	Sedan
<b>Colour</b>	Red

## Body / Panel Condition

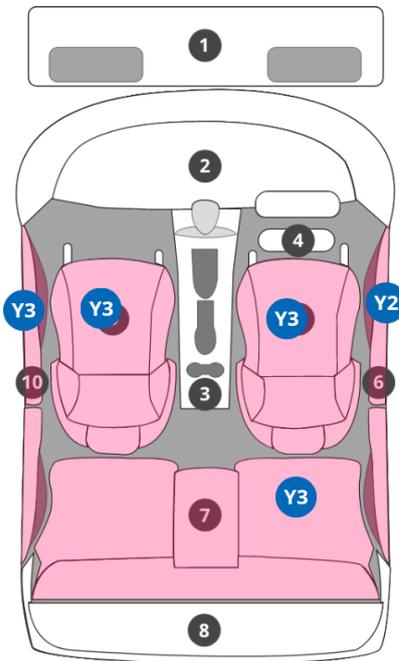
<p><b>A</b> : Scratch <b>AU</b> : Scratch &amp; Dent <b>B</b> : Modified <b>C</b> : Corrosion <b>G</b> : Stone chip <b>P</b> : Faded <b>S</b> : Rust <b>SC</b> : Rust &amp; Corrosion <b>U</b> : Dent <b>X</b> : Defective <b>Y</b> : Crack, Gap</p>
<p><b>Remarks</b> Rear Seat - Grime - Medium / (R) Front Seat - Grime - Medium / (R) Front Trim - Grime - Small / (L) Front Seat - Grime - Medium / (L) Front Trim - Grime - Medium</p>	<p><b>Remarks</b> Defects not found</p>
<b>Frame Evaluation :</b> <span style="float: right;"><b>A</b></span>	<b>Functional Evaluation :</b> <span style="float: right;"><b>A</b></span>
