## General Information

<b>Make</b>	Toyota	<b>Model</b>	Vios
<b>YOM</b>	2024	<b>Mileage</b>	25,577
<b>Registration No.</b>	NHC9774	<b>Chassis No.</b>	PA1B18F34P4229889
<b>CC</b>	1.3	<b>Transmission</b>	CVT
<b>Fuel Type</b>	Gas	<b>Type of Body</b>	Sedan
<b>Colour</b>	Red Mica Metallic

## Body / Panel Condition

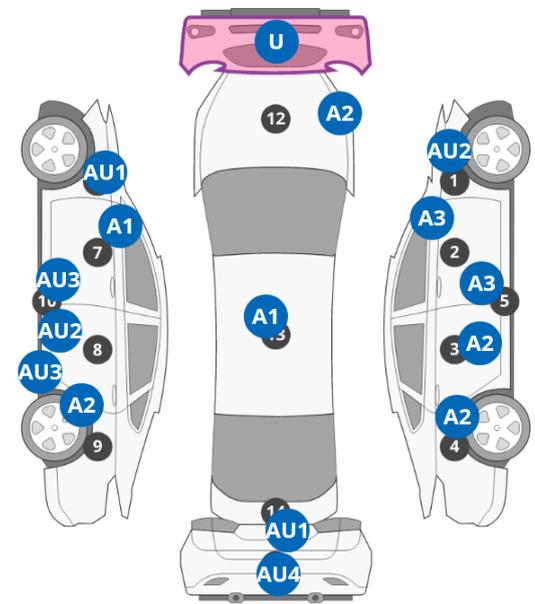
<p><b>A</b> : Scratch <b>AU</b> : Scratch &amp; Dent <b>B</b> : Modified <b>C</b> : Corrosion <b>G</b> : Stone chip <b>P</b> : Faded <b>S</b> : Rust <b>SC</b> : Rust &amp; Corrosion <b>U</b> : Dent <b>X</b> : Defective <b>Y</b> : Crack, Gap</p>
<p><b>Remarks</b> (L) Front Trim - Grime - Minimal / Glove Box - Worn, Scratch, Cut, Crack - Minimal / (R) Rear Trim - Grime - Minimal / Trunk Room - Worn, Scratch, Cut, Crack - Minimal / Rear Seat - Grime - Minimal / (R) Front Seat - Grime - Minimal / (L) Rear Trim - Grime - Minimal / (L) Front Seat - Grime - Minimal / Overall Interior - Smell - Yes</p>	<p><b>Remarks</b> (R) Front Fender, Molding - Scratch &amp; Dent - Small / (R) Mirror - Scratch - Medium / (R) Front Door, Molding - Scratch - Medium / (R) Rear Door, Molding - Scratch - Small / (R) Rear Fender, Molding - Scratch - Small / Rear Bumper, Lamps, Panels - Scratch &amp; Dent - Large / Trunk Hood, Rear Gate - Scratch &amp; Dent - Minimal / (L) Step, In-panel, Side Spoiler - Scratch &amp; Dent - Medium / (L) Rear Fender, Molding - Scratch - Small / (L) Rear Door, Molding - Scratch &amp; Dent - Small / (L) Front Door, Molding - Scratch &amp; Dent - Medium / (L) Mirror - Scratch - Minimal / Roof - Scratch - Minimal / (L) Front Fender, Molding - Scratch &amp; Dent - Minimal / Front Bumper, Grille, Lamps - Repair mark - Yes / Member (Bolted) - Dent - Yes / Bonnet, Headlight - Scratch - Small</p>
