## General Information

Date & Time: 26, Mar, 2025 13:24

<b>Make</b>	Toyota	<b>Model</b>	Vios
<b>YOM</b>	2024	<b>Mileage</b>	25,349
<b>Registration No.</b>	NHM2496	<b>Chassis No.</b>	PA1B18F37P4236108
<b>CC</b>	1.3	<b>Transmission</b>	CVT
<b>Fuel Type</b>	Gas	<b>Type of Body</b>	Sedan
<b>Colour</b>	Silver

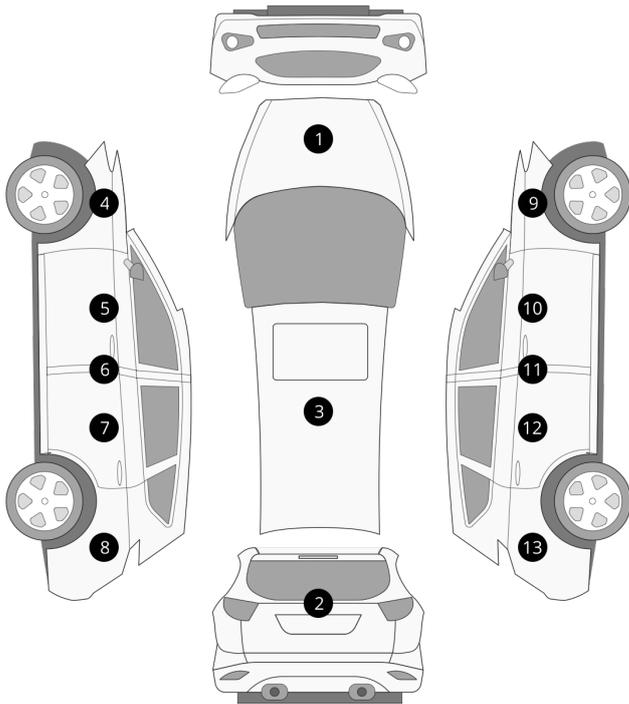
#	Area	Thickness(um)			
		Average	Value1	Value2	Value3/4
1	Bonnet	105.3	107	108	101
2	Boot Lid	108.6	105	108	113
3	Roof	112.0	102	126	113/107
4	Left Front Fender	104.5	89	97	127
5	Left Front Door	100.9	95	102	106
6	Center Panel Left				
7	Left Rear Door	98.5	100	96	100
8	Left Back Panel	105.0	106	102	107
9	Right Front Fender	106.0	103	104	111
10	Right Front Door	103.6	105	104	102
11	Center Panel Right				
12	Right Rear Door	111.0	107	113	113
13	Right Back Panel	110.3	107	120	104

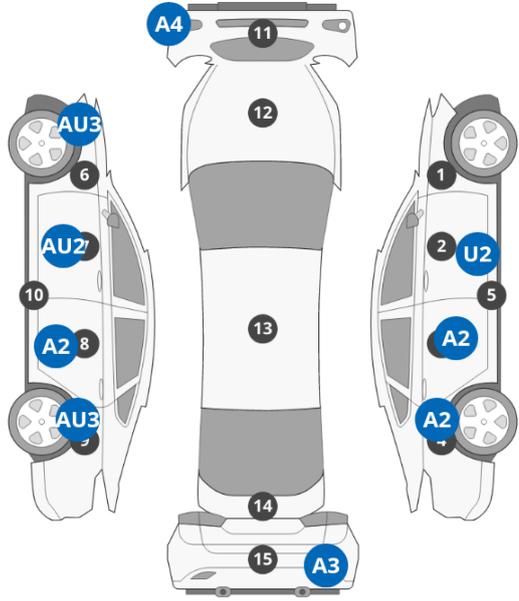
<p><b>A</b> : Scratch <b>AU</b> : Scratch &amp; Dent <b>B</b> : Modified <b>C</b> : Corrosion <b>G</b> : Stone chip <b>P</b> : Faded <b>S</b> : Rust <b>SC</b> : Rust &amp; Corrosion <b>U</b> : Dent <b>X</b> : Defective <b>Y</b> : Crack, Gap</p>
<p><b>Remarks</b> (R) Front Floor Mat - Missing - Yes / (L) Front Floor Mat - Missing - Yes / Mat Other - Missing - Yes / (R) Front Seat - Grime - Large / (L) Front Seat - Grime - Large / Overall Interior - Worn as per age - Yes / Dashboard - Traces of Adhesive Tape - Yes / Overall Interior - Smell - Yes</p>	<p><b>Remarks</b> (R) Front Door, Molding - Dent - Small / (R) Rear Fender, Molding - Scratch - Small / Rear Bumper, Lamps, Panels - Scratch - Medium / (R) Rear Door, Molding - Scratch - Small / (L) Rear Door, Molding - Scratch - Small / (L) Front Door, Molding - Scratch &amp; Dent - Small / (L) Rear Fender, Molding - Scratch &amp; Dent - Medium / (L) Front Fender, Molding - Scratch &amp; Dent - Medium / Front Bumper, Grille, Lamps - Scratch - Large</p>
