## General Information

<b>Make</b>	Toyota	<b>Model</b>	Vios
<b>YOM</b>	2025	<b>Odo Meter Reading</b>	772
<b>Registration No.</b>	NJA1941	<b>Chassis No.</b>	PA1B18F32R4280522
<b>CC</b>	1.3	<b>Transmission</b>	CVT
<b>Fuel Type</b>	Gas	<b>Type of Body</b>	Sedan
<b>Colour</b>	Silver

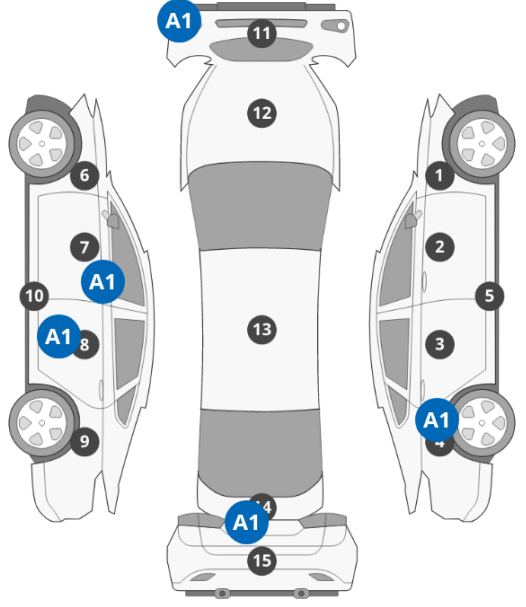
<p><b>A</b> : Scratch <b>AU</b> : Scratch &amp; Dent <b>B</b> : Modified <b>C</b> : Corrosion <b>G</b> : Stone chip <b>P</b> : Faded <b>S</b> : Rust <b>SC</b> : Rust &amp; Corrosion <b>U</b> : Dent <b>X</b> : Defective <b>Y</b> : Crack, Gap</p>
<b>Remarks</b> Defects not found	<b>Remarks</b> Front Bumper, Grille, Lamps - Scratch - Minimal / (R) Rear Fender, Molding - Scratch - Minimal / Trunk Hood, Rear Gate - Scratch - Minimal / (L) Rear Door, Molding - Scratch - Minimal / (L) Front Door, Molding - Scratch - Minimal
<b>Frame Evaluation :</b> <span style="color: red; font-weight: bold; font-size: 1.2em;">A</span>	<b>Functional Evaluation :</b> <span style="color: red; font-weight: bold; font-size: 1.2em;">A</span>
