## General Information

| Make | Toyota | Model | Avanza |
| Registration No. | EAG7220 | Chassis No. | MHFAA1BY6P0022142 |

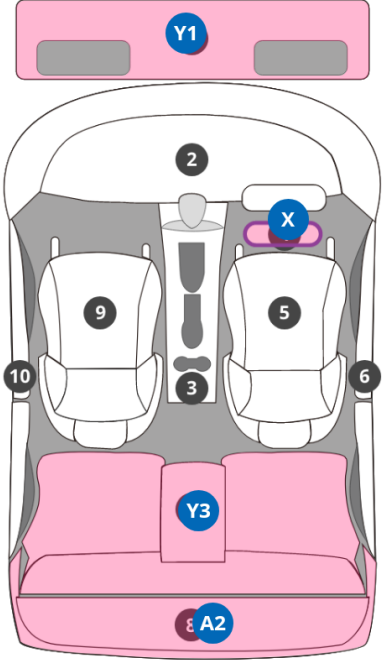
| <b>Interior Evaluation :</b> <b>B</b> | <b>Exterior Evaluation :</b> <b>D</b> |
| <b>Remarks</b><br>Rear Seat - Grime - Medium / Trunk Room - Worn, Scratch, Cut, Crack - Small / Mat Other - Missing - Yes / Ceiling - Grime - Minimal | <b>Remarks</b><br>(L) Rear Door - Repair Traces - Yes / (R) Rear Door - Repair Traces - Yes / Roof - Repair Traces - Yes / (R) Rear Fender, Molding - Repair mark - Yes / Rear Bumper, Lamps, Panels - Repair mark - Yes / (L) Rear Fender, Molding - Repair mark - Yes / (R) Front Fender, Molding - Scratch - Minimal / (R) Mirror - Scratch - Minimal / (R) Front Door, Molding - Scratch - Small / (R) Rear Door, Molding - Scratch - Medium / Trunk Hood, Rear Gate - Scratch - Small / (L) Rear Door, Molding - Scratch - Small / (L) Front Door, Molding - Scratch - Minimal / (L) Mirror - Scratch - Minimal / (L) Front Fender, Molding - Scratch - Small / Front Bumper, Grille, Lamps - Scratch - Large / Bonnet, Headlight - Scratch - Small / Roof - Repair mark - Yes / Roof - Dent - Large |
