## General Information

| Make | Toyota | Model | Vios |
| YOM | 2022 | Mileage | 106,014 |
| Registration No. | NFK8501 | Chassis No. | PA1B18F39N4171307 |

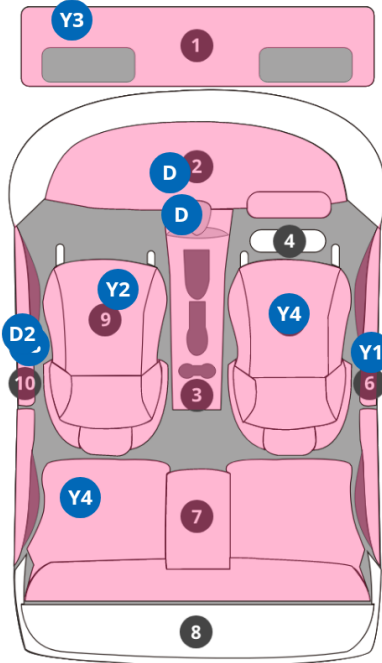
| Interior Evaluation : <b>C</b> | Exterior Evaluation : <b>E</b> |
|---|---|
| <p><b>Remarks</b></p> <p>(R) Front Seat - Grime - Large / (R) Front Trim - Grime - Minimal / (L) Front Trim - Grime - Medium / (L) Front Trim - Worked - Small / Rear Seat - Grime - Large / Console, Switchs, Vents - Traces of Adhesive Tape - Yes / Dashboard - Traces of Adhesive Tape - Yes / Overall Interior - Worn as per age - Yes / Ceiling - Grime - Medium / (L) Front Seat - Grime - Small</p> | <p><b>Remarks</b></p> <p>(R) Front Door - Repair Traces - Yes / (R) Front Fender - Repair Traces - Yes / (L) Front Fender - Repair Traces - Yes / (L) Front Door - Repair Traces - Yes / (L) Rear Fender - Repair Traces - Yes / Trunk Hood, Rear Gate - Repair Traces - Yes / (R) Rear Fender - Repair Traces - Yes / (R) Rear Door - Repair Traces - Yes / Roof - Repair Traces - Yes / (R) Front Fender, Molding - Scratch &amp; Dent - Medium / (R) Mirror - Scratch - Small / (R) Rear Fender, Molding - Scratch &amp; Dent - Large / (R) Front Door, Molding - Scratch &amp; Dent - Medium / (R) Step, In-panel, Side Spoiler - Scratch &amp; Dent - Medium / (R) Rear Door, Molding - Scratch - Large / Rear Bumper, Lamps, Panels - Scratch &amp; Dent - Large / Trunk Hood, Rear Gate - Scratch &amp; Dent - Small / (L) Rear Fender, Molding - Scratch &amp; Dent - Large / (L) Mirror - Scratch - Small / (L) Rear Door, Molding - Scratch &amp; Dent - Medium / (L) Front Door, Molding - Scratch - Medium / (L) Front Fender, Molding - Scratch &amp; Dent - Medium / Bonnet, Headlight - Rust, Corrosion - Large / Front Bumper, Grille, Lamps - Scratch &amp; Dent - Large / Roof - Dent - Medium</p> |
