## General Information

| Make | Toyota | Model | Vios |
| Registration No. | NFR6005 | Chassis No. | PA1B18F3XR4252659 |

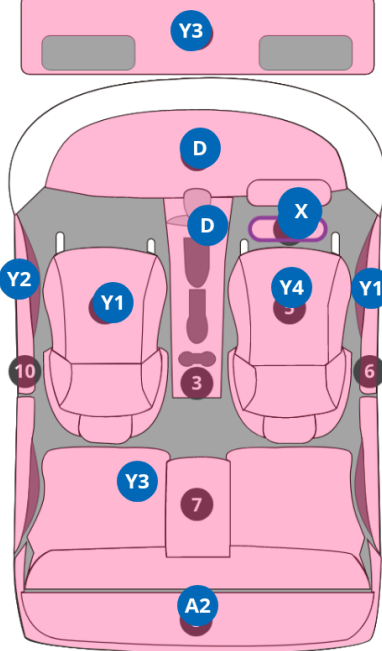
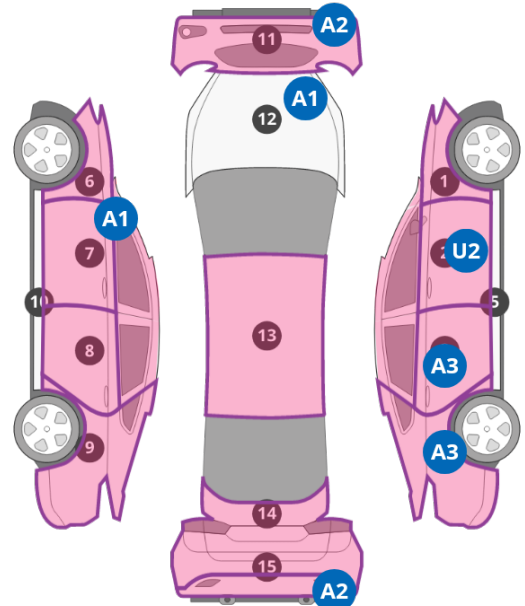
| Interior Evaluation : <b>C</b> | Exterior Evaluation : <b>E</b> |
|---|---|
| <b>Remarks</b><br>(L) Front Floor Mat - Missing - Yes / (R) Front Floor Mat - Missing - Yes / Mat Other - Missing - Yes / (R) Front Seat - Grime - Large / (R) Front Trim - Grime - Minimal / Rear Seat - Grime - Medium / Trunk Room - Worn, Scratch, Cut, Crack - Small / (L) Front Seat - Grime - Minimal / Dashboard - Traces of Adhesive Tape - Yes / Console, Switches, Vents - Traces of Adhesive Tape - Yes / (L) Front Trim - Grime - Small / Ceiling - Grime - Medium | <b>Remarks</b><br>(R) Front Door, Molding - Repair mark - Yes / (R) Rear Door, Molding - Repair mark - Yes / (R) Rear Fender, Molding - Repair mark - Yes / Roof - Repair mark - Yes / Rear Bumper, Lamps, Panels - Repair mark - Yes / Trunk Hood, Rear Gate - Repair mark - Yes / (L) Rear Door, Molding - Repair mark - Yes / (L) Front Door, Molding - Repair mark - Yes / (L) Rear Fender, Molding - Repair mark - Yes / (L) Front Fender, Molding - Repair mark - Yes / Front Bumper, Grille, Lamps - Repair mark - Yes / (R) Front Fender, Molding - Repair mark - Yes / (R) Front Door, Molding - Dent - Small / (R) Rear Door, Molding - Scratch - Medium / (R) Rear Fender, Molding - Scratch - Medium / Rear Bumper, Lamps, Panels - Scratch - Small / (L) Mirror - Scratch - Minimal / Front Bumper, Grille, Lamps - Scratch - Small / Bonnet, Headlight - Scratch - Minimal |

| Inspector Notes |
|---|
| No spare tire/No LTO plate/No jack and tools/No warranty booklet/repair marks around the vehicle/possible flooding |
