## General Information

| Make | Toyota | Model | Innova |
| YOM | 2024 | Mileage | 19,134 |
| Registration No. | NKI6923 | Chassis No. | PA2JA8EM7R0142340 |

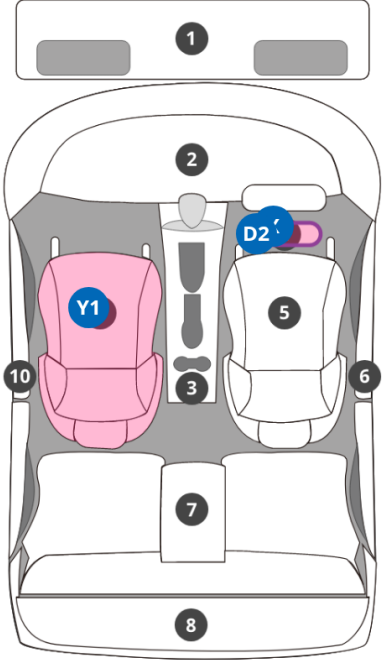
| Interior Evaluation : <b>B</b> | Exterior Evaluation : <b>E</b> |
| <p><b>Remarks</b><br/>Mat Other - Missing - Yes / (L) Front Seat - Grime - Minimal / (L) Front Floor Mat - Worked - Small</p> | <p><b>Remarks</b><br/>(R) Front Door - Repair Traces - Yes / (R) Front Fender - Repair Traces - Yes / Bonnet - Repair Traces - Yes / (L) Front Fender - Repair Traces - Yes / (L) Front Door - Repair Traces - Yes / (L) Rear Door - Repair Traces - Yes / (L) Rear Fender - Repair Traces - Yes / Trunk Hood, Rear Gate - Repair Traces - Yes / (R) Rear Fender - Repair Traces - Yes / (R) Rear Door - Repair Traces - Yes / Roof - Repair Traces - Yes / Bonnet, Headlight - Repair mark - Yes / (L) Front Fender, Molding - Repair mark - Yes / (R) Front Fender, Molding - Repair mark - Yes / Roof - Scratch &amp; Dent - Large / (L) Rear Door, Molding - Scratch - Small / Front Bumper, Grille, Lamps - Crack, Gap - Large / (R) Front Fender, Molding - Crack, Gap - Large / (R) Step, In-panel, Side Spoiler - Scratch &amp; Dent - Medium / Member (Bolted) - Dent - Yes / (R) Rear Door, Molding - Scratch - Large / Front Bumper, Grille, Lamps - Repair mark - Yes / Rear Bumper, Lamps, Panels - Scratch - Minimal / (L) Rear Fender, Molding - Scratch - Minimal / (R) Rear Fender, Molding - Scratch - Small</p> |
