## General Information

| Make | Toyota | Model | Veloz |
| Registration No. | NHM5031 | Chassis No. | MHFAB1BYXP3082324 |

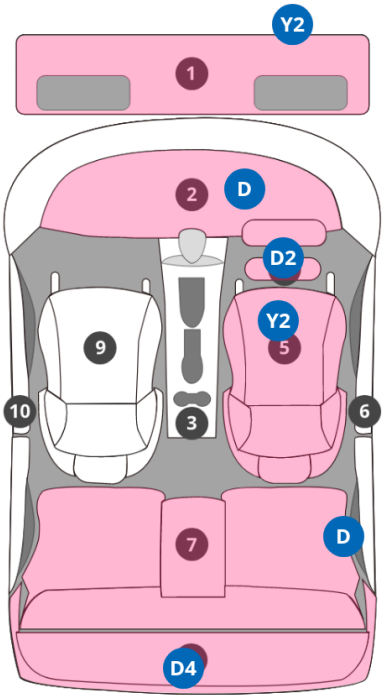
| Interior Evaluation : <span>C</span> | Exterior Evaluation : <span>C</span> |
|---|---|
| <b>Remarks</b><br>Trunk Room - Worked - Large / Rear Seat - Worn - Yes / (R) Front Seat - Grime - Small / (L) Front Floor Mat - Worked - Small / Ceiling - Grime - Small / Dashboard - Traces of Adhesive Tape - Yes | <b>Remarks</b><br>(R) Rear Fender, Molding - Partially Missing - Yes / (R) Front Fender, Molding - Scratch - Small / (R) Front Door, Molding - Scratch & Dent - Small / (R) Step, In-panel, Side Spoiler - Scratch - Small / (R) Rear Door, Molding - Scratch - Minimal / Rear Bumper, Lamps, Panels - Scratch - Minimal / (L) Rear Fender, Molding - Scratch - Minimal / (L) Rear Door, Molding - Scratch - Minimal / (L) Front Door, Molding - Scratch - Minimal / (L) Mirror - Scratch - Small / Front Bumper, Grille, Lamps - Scratch - Small / Bonnet, Headlight - Scratch - Minimal / Roof - Rust, Corrosion - Minimal |
